LION HOUSE, COMMERCIAL STREET, PONTYPOOL.  
LBC ROOM CONDITION INSPECTION.

PHOTOGRAPHS.

13-P-00110

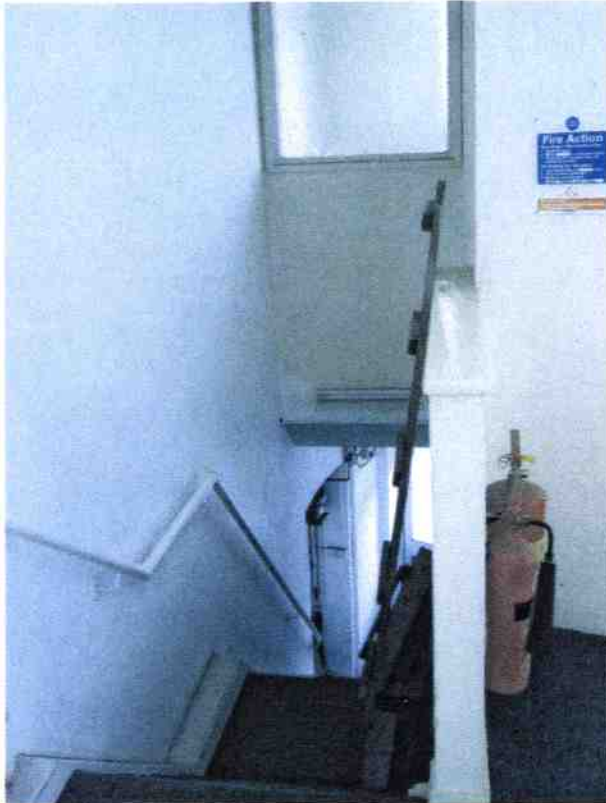
1. F1 First floor landing + staircase from street.

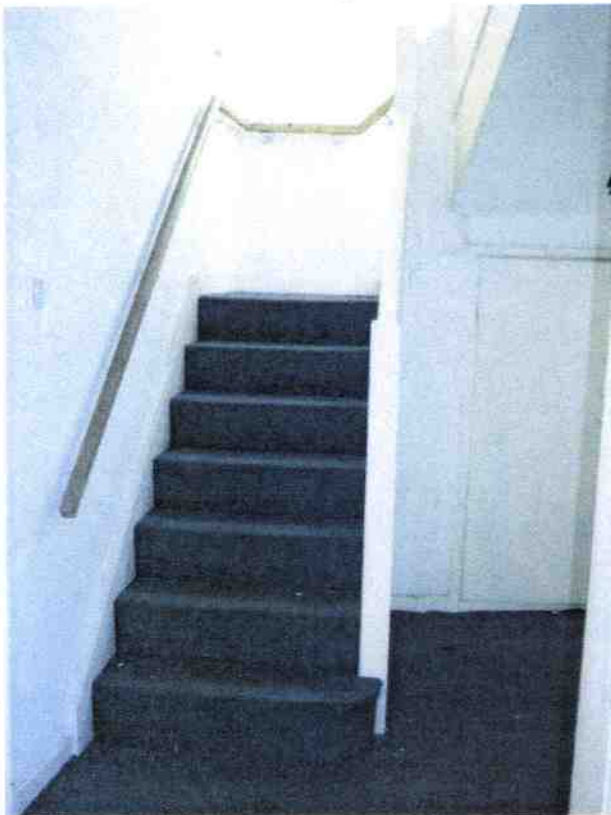
2. F1 First floor landing + staircase to second floor

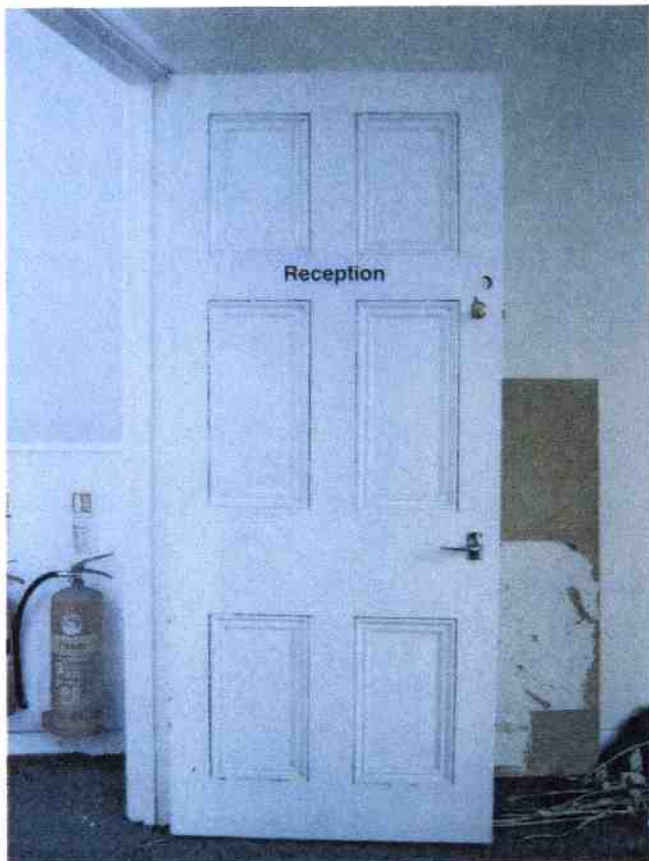
3. F2 office entrance door from landing D1

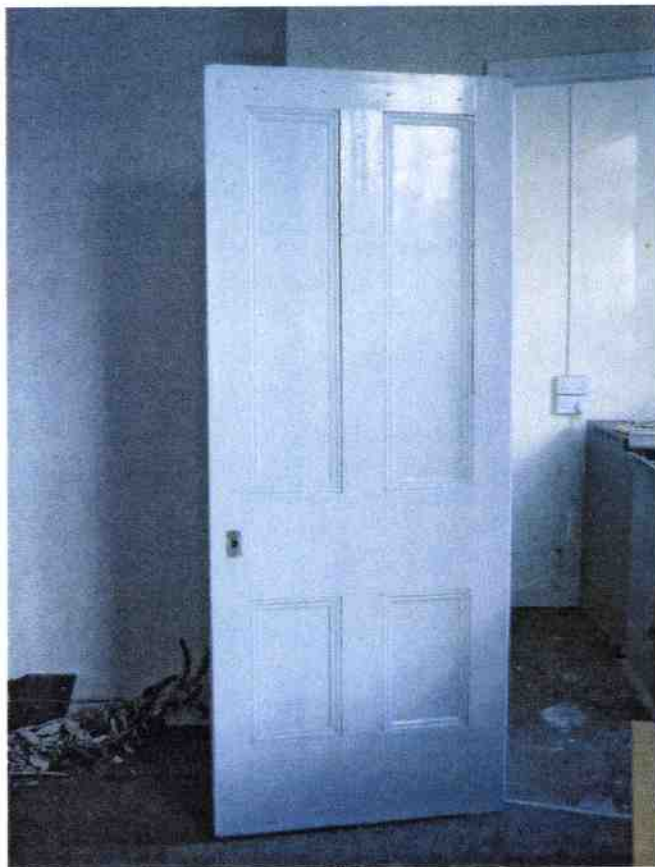
4. F2 office D3 to inner office F3.

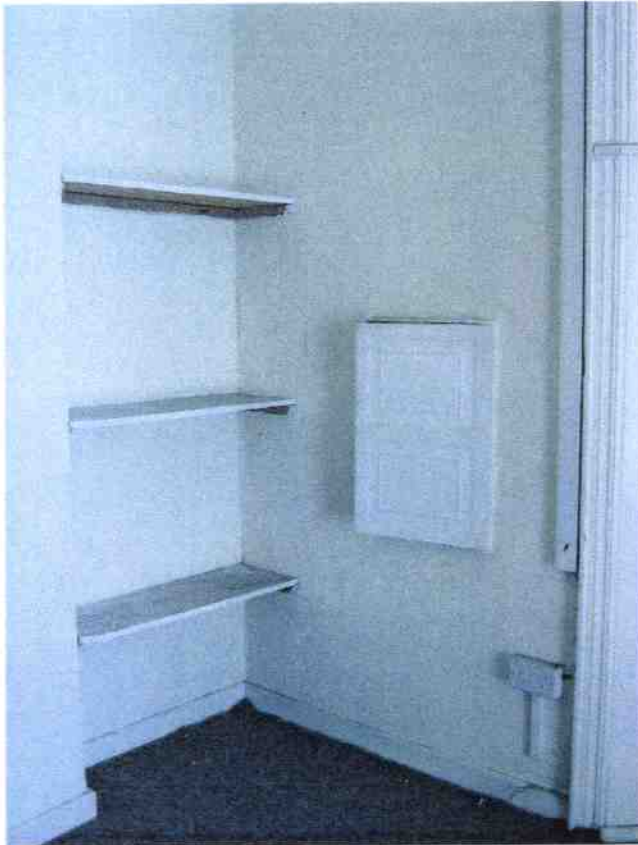
5. F4 office wall safe and shelves.

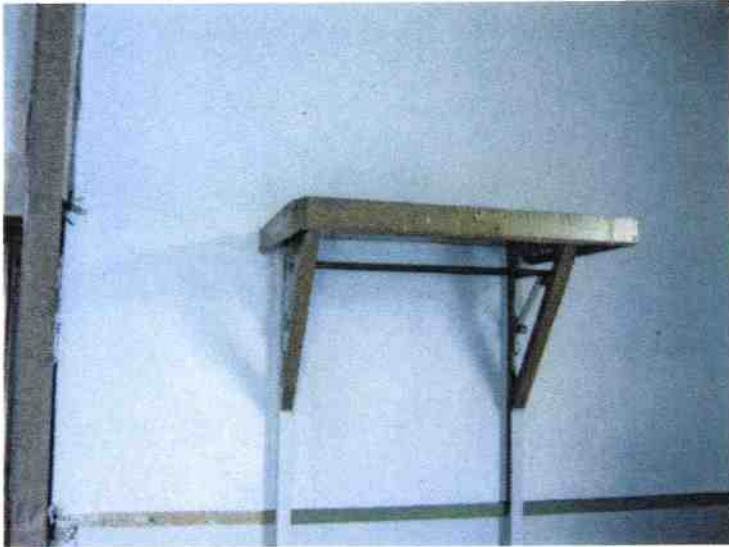
7. F5 office wall bracket.

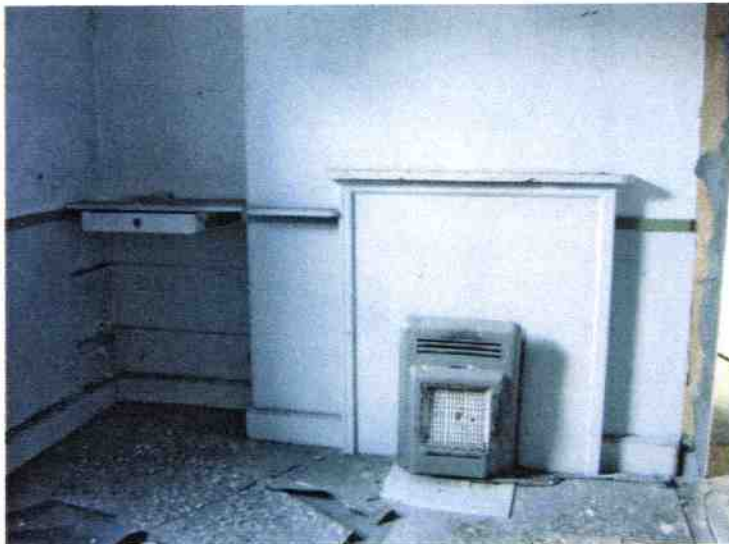
8. F5 fire place and gas fire.

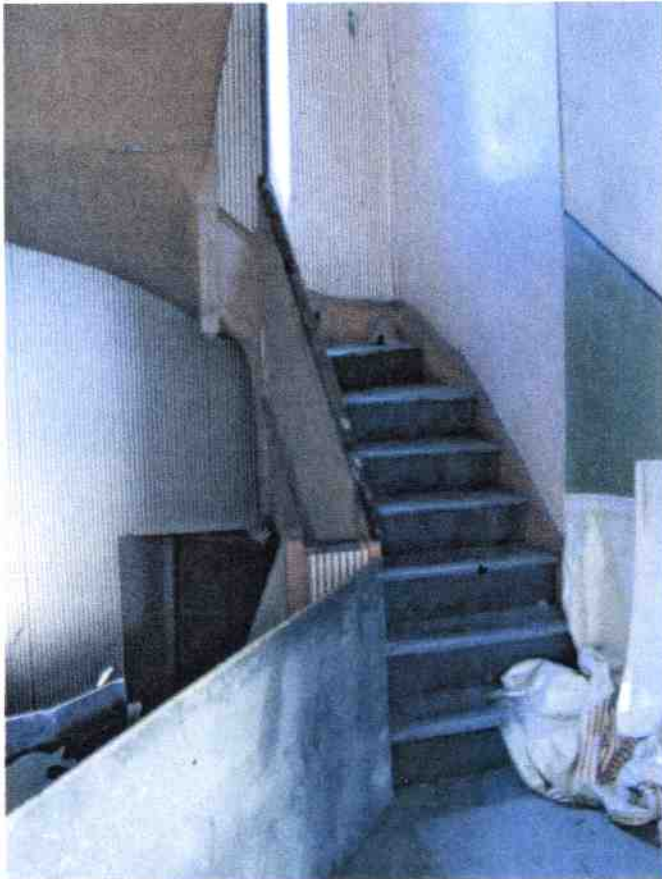
12. F7 landing, stairs to second floor.

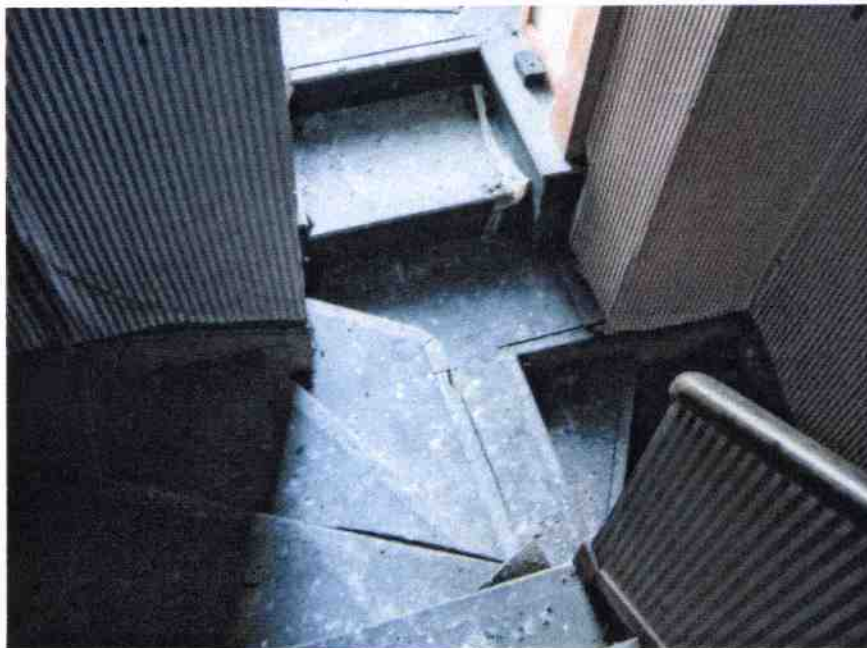
13. F7 stairs to half landing – access to rear wc.

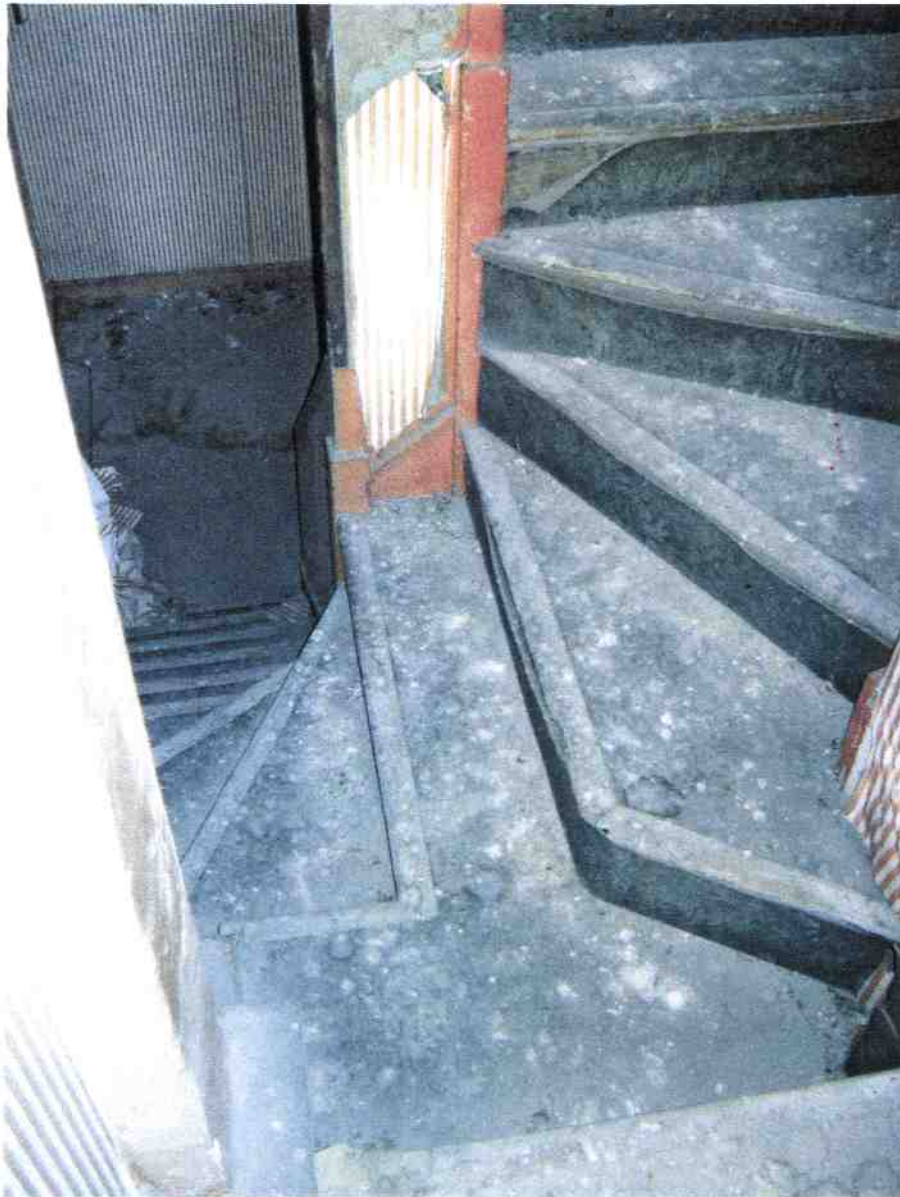
14. F7. Stairs at half landing.

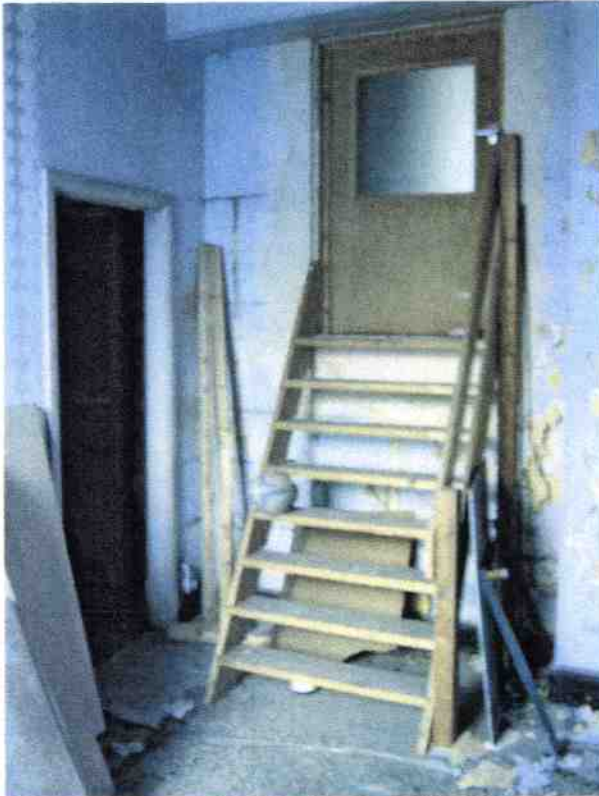
15. F8. Short ladder to F10. D9.

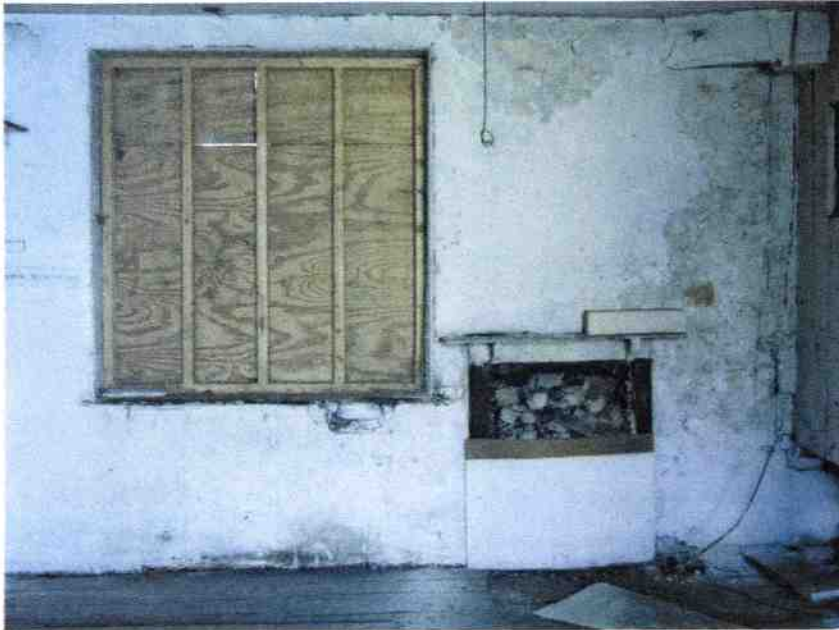
17. W17 – boarded opening. Adjacent fire place opening.

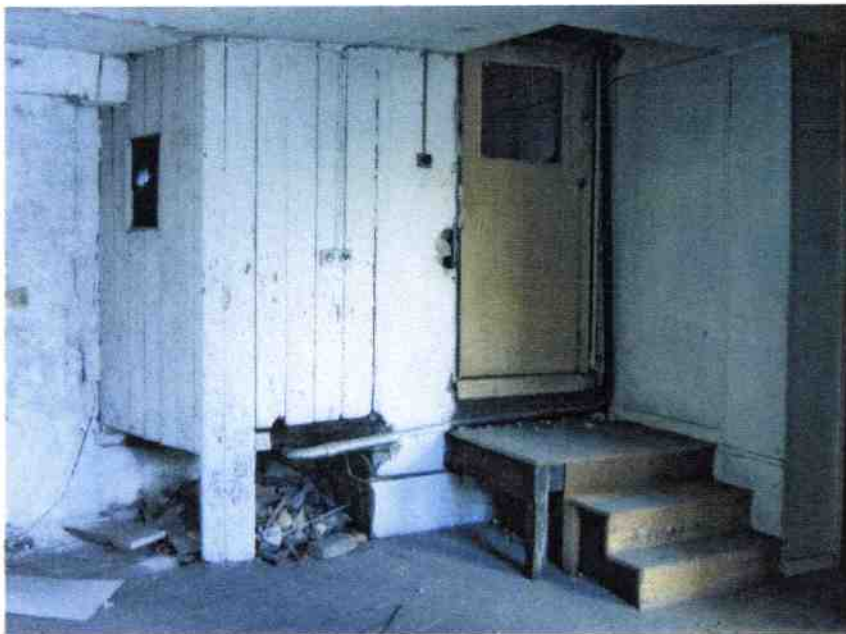
18. F10 D8 and access steps.

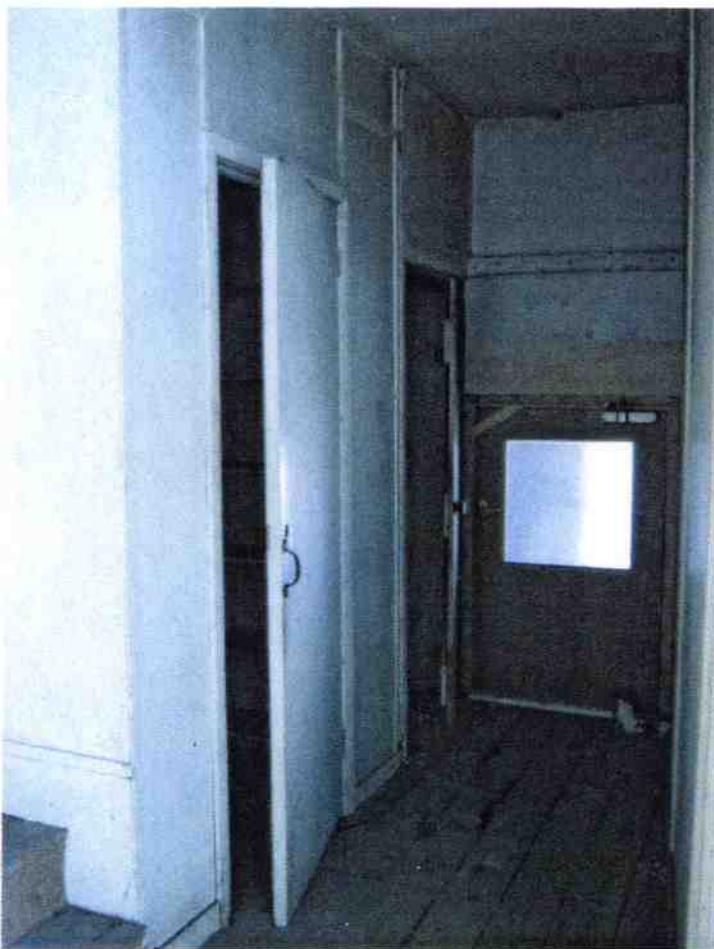
19. F10 looking toward D11, D10 and D9.

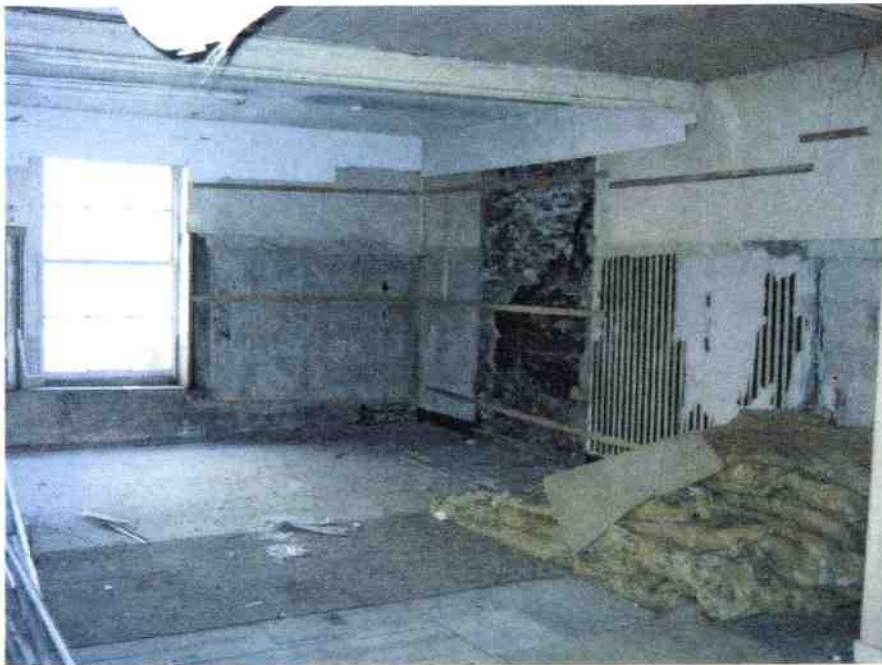
21. F17 Looking towards W10 + removed fireplace.

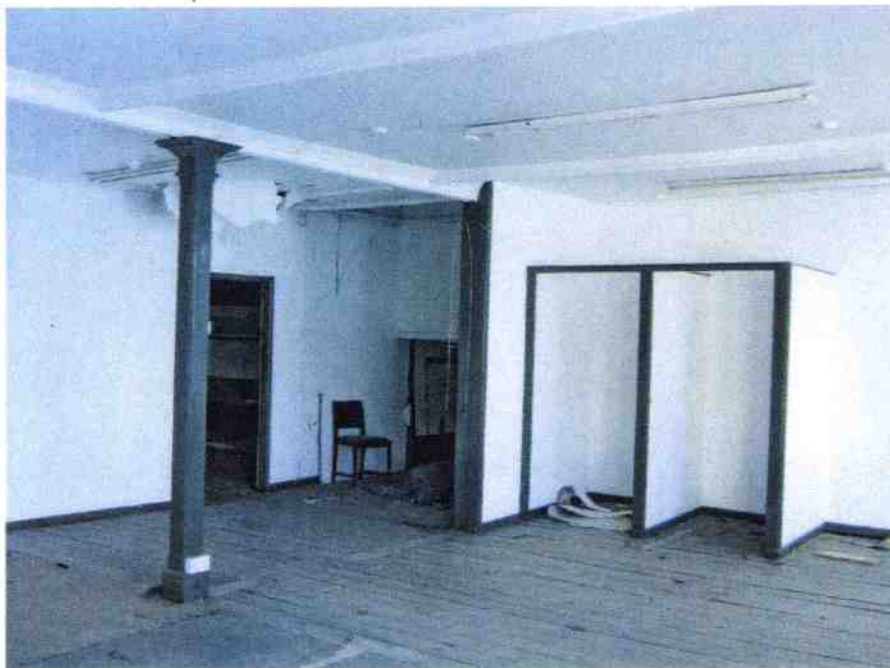
22. F17 Looking towards rear changing cubicles.  
Central support timber post.

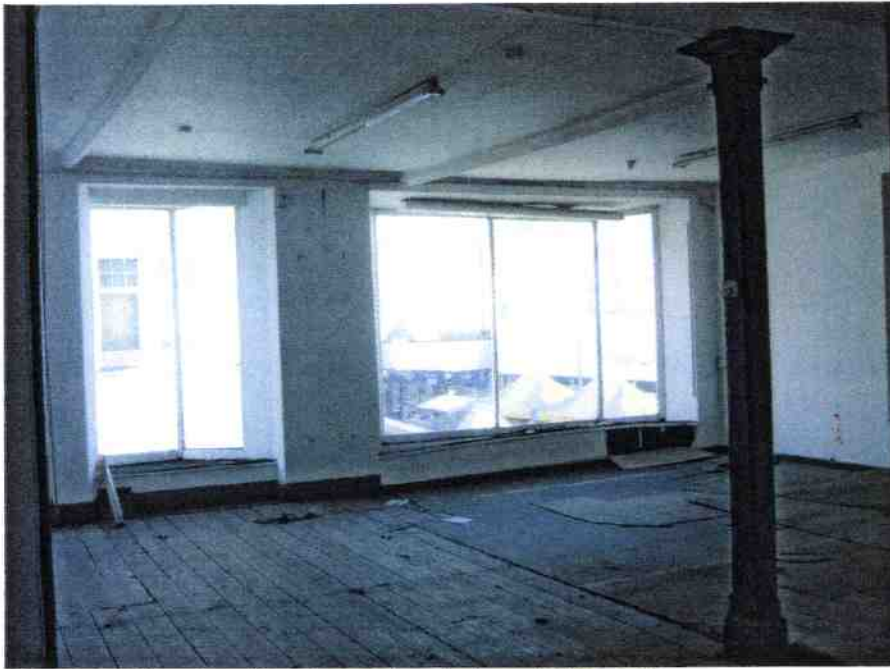
22. F17 Looking towards windows W12 + 13.  
Central support timber post.

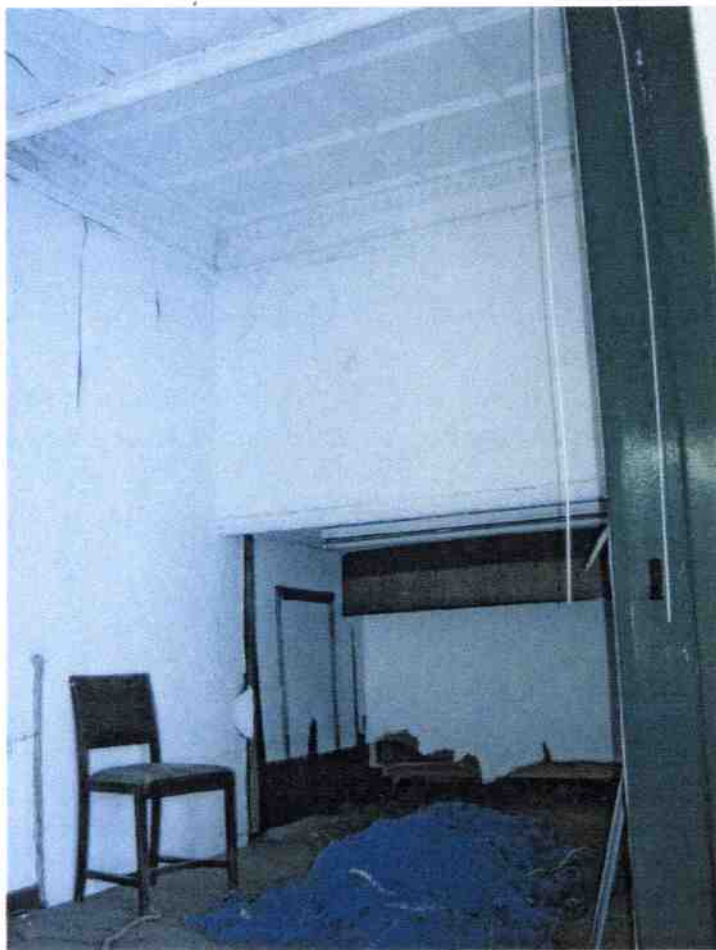
24. F17 rear bulkhead and ceiling recess.

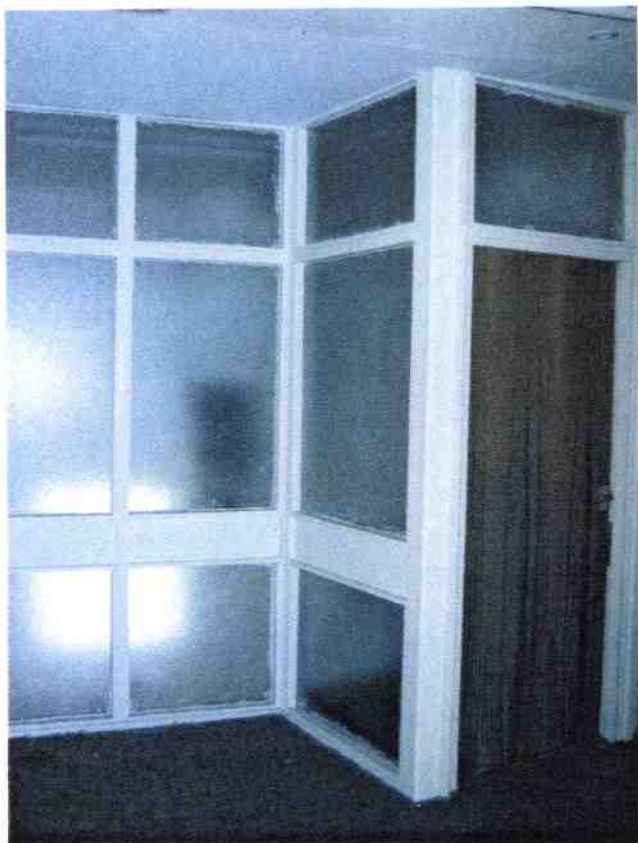
25. S1. Landing. Fire screen and D21.

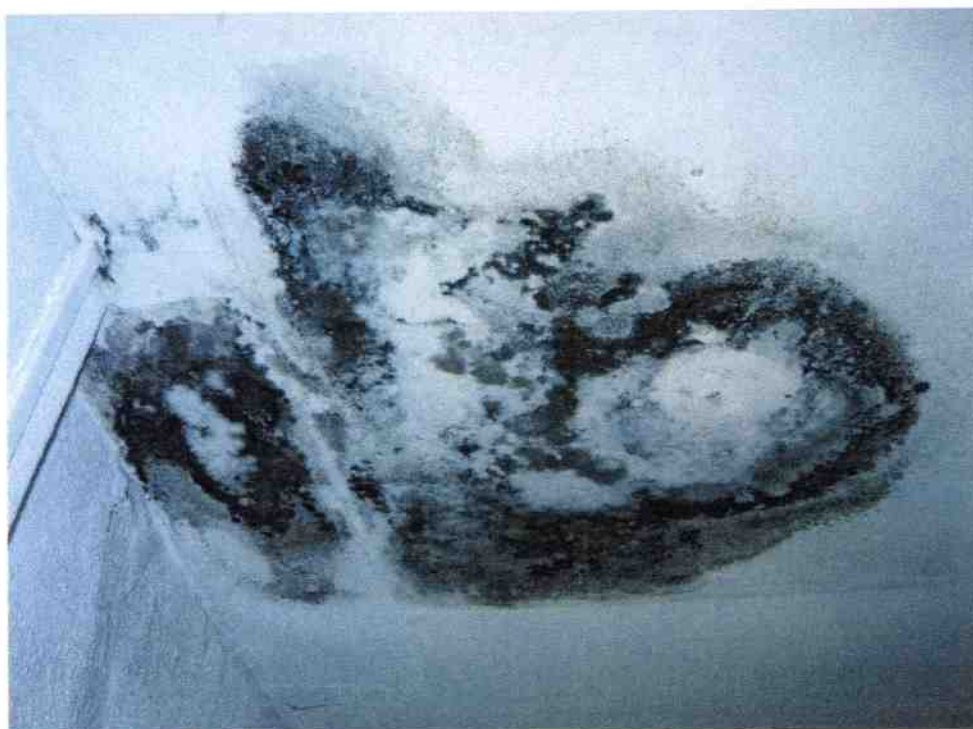
26. S1. Damp staining to ceiling

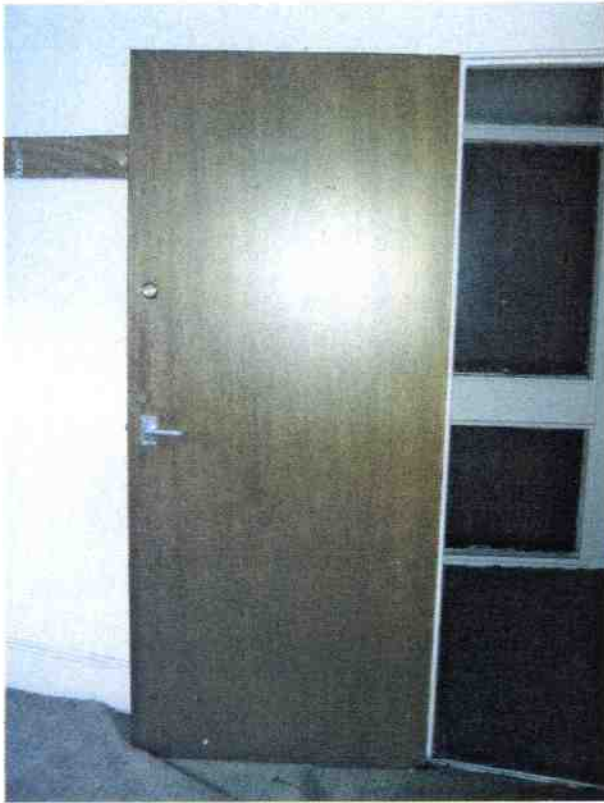
27. S4. D22. (Typical flush fire door)

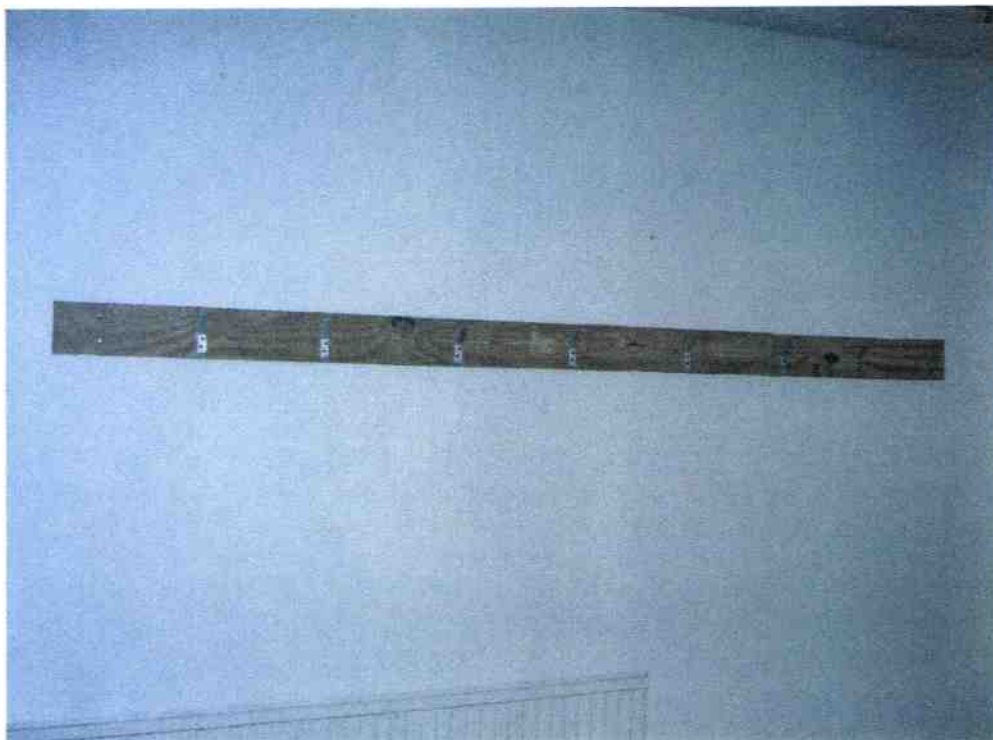
28. S2. Coat hooks to wall.

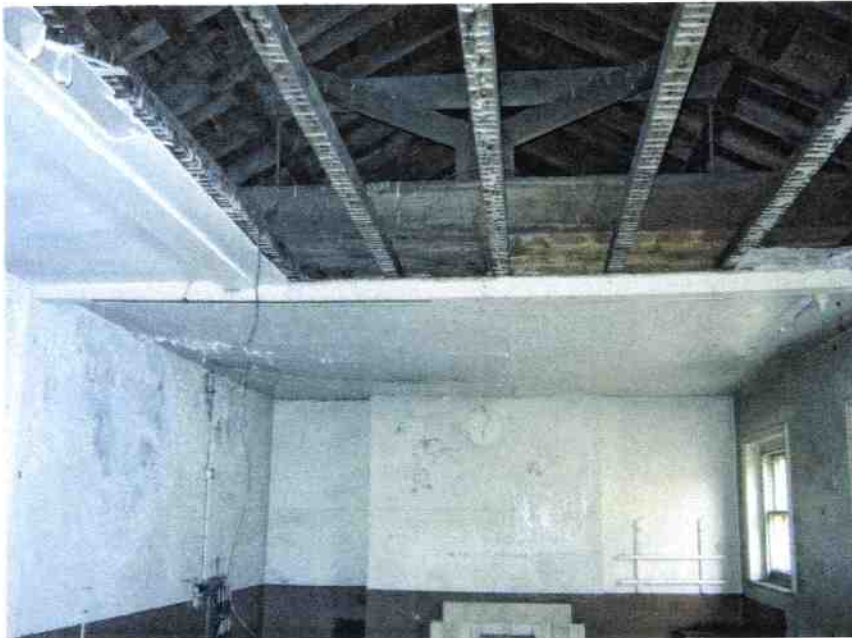
29. S5. Ceiling – damaged by extensive water ingress.

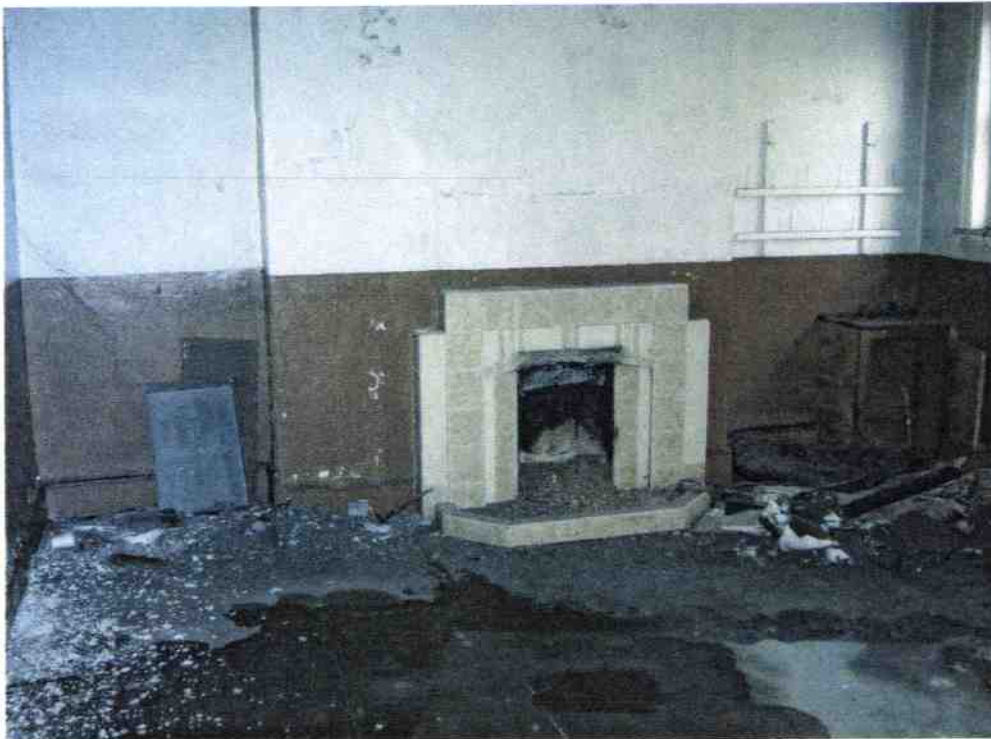
30. S5. Fireplace. N wall.

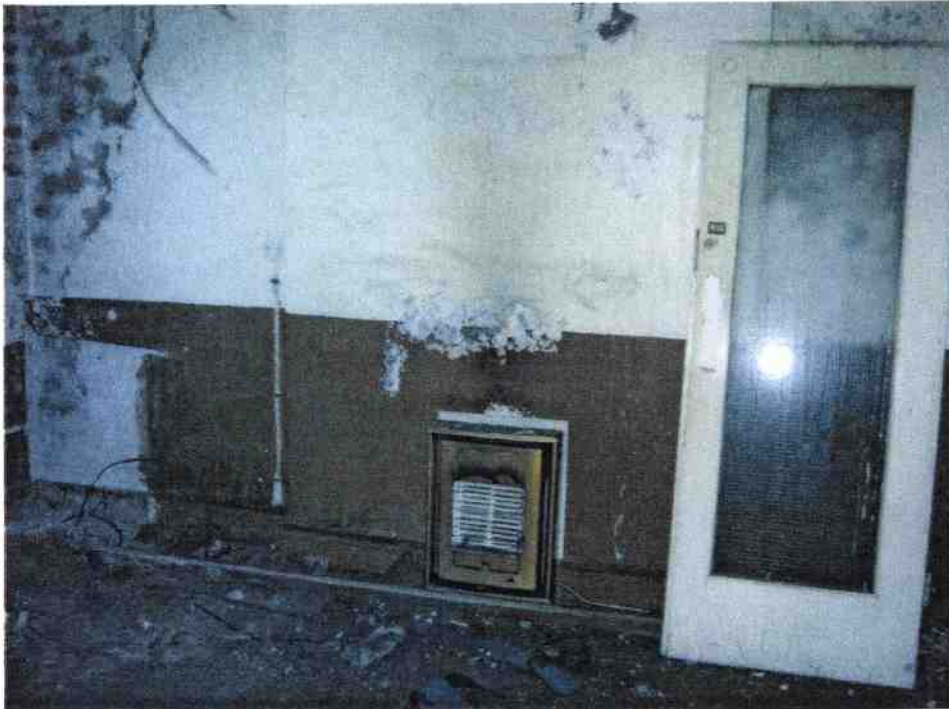
31. S5 Gas fire. S wall.

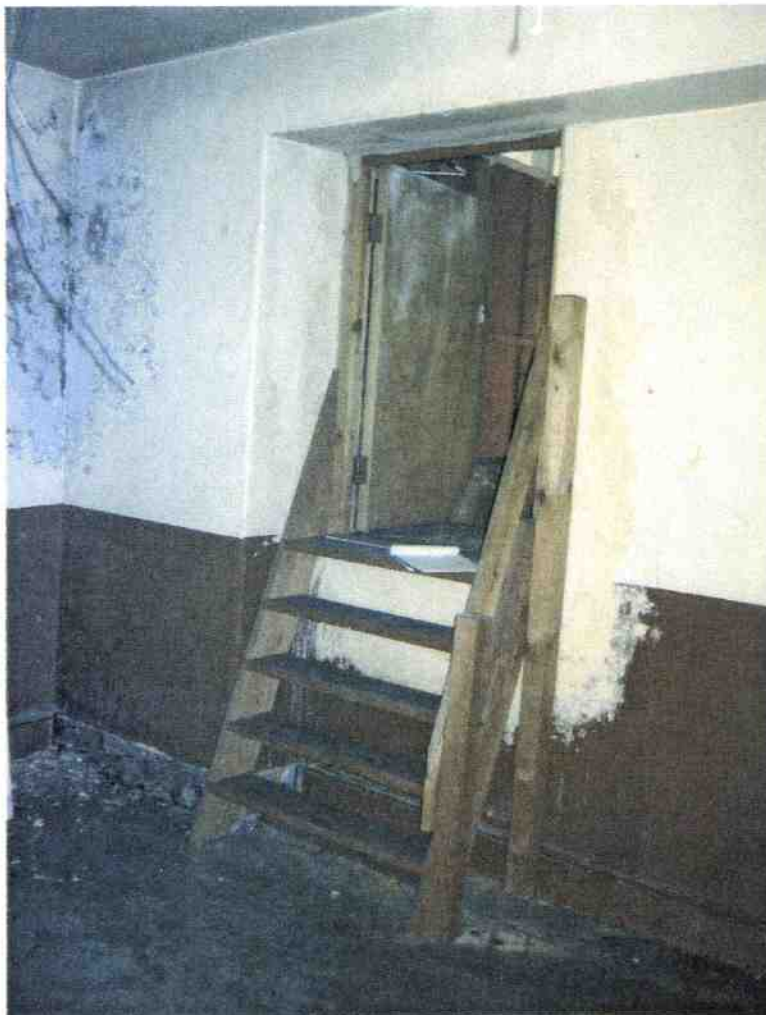
32. S5 Ladder to upper level (S8) + D33.

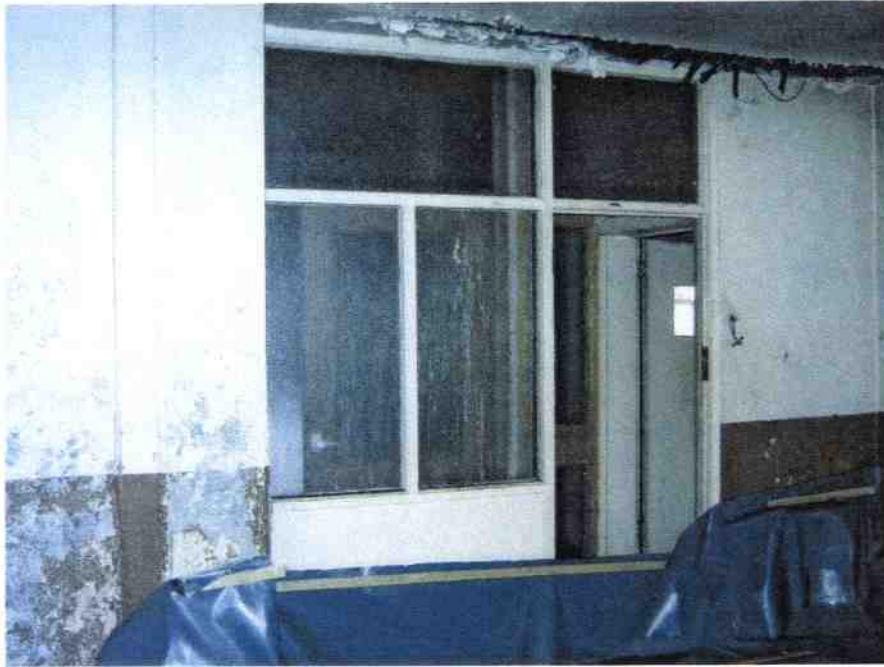
33. S5 Fire screen from landing S7.  
Polythene sheeting on floor.

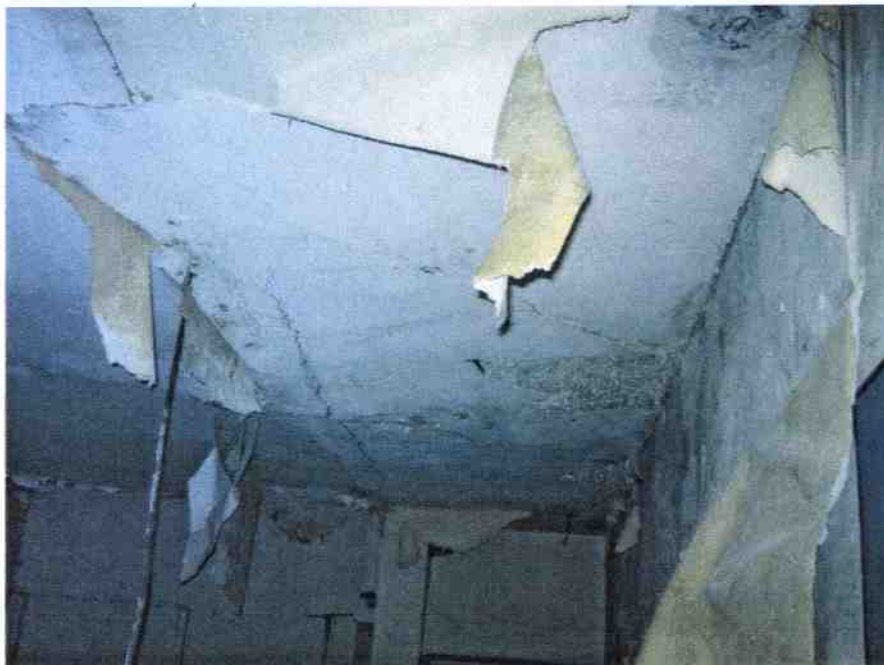
34. S6 Ceiling damage.

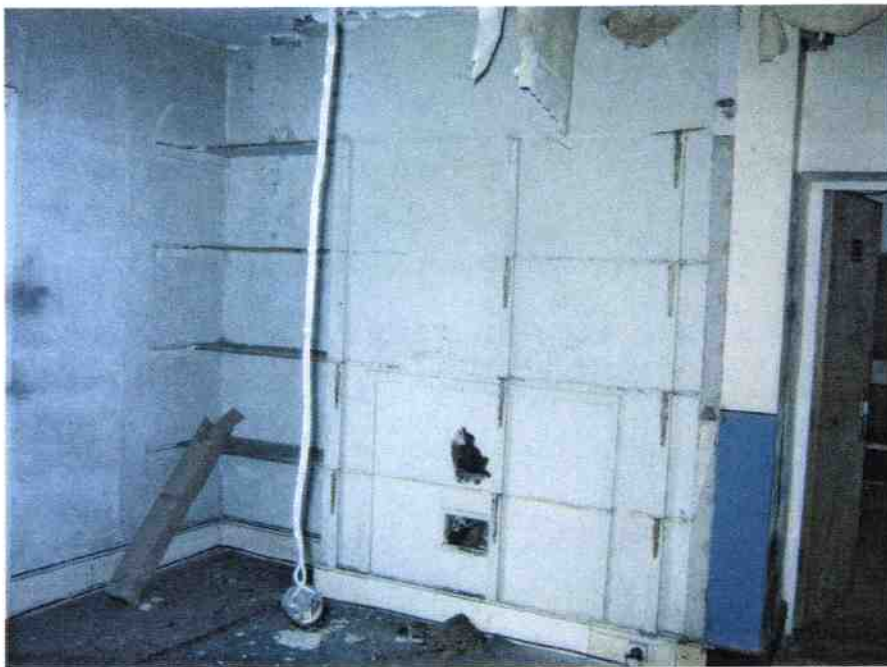
35. S6 Internal N fireplace wall + shelf brackets.

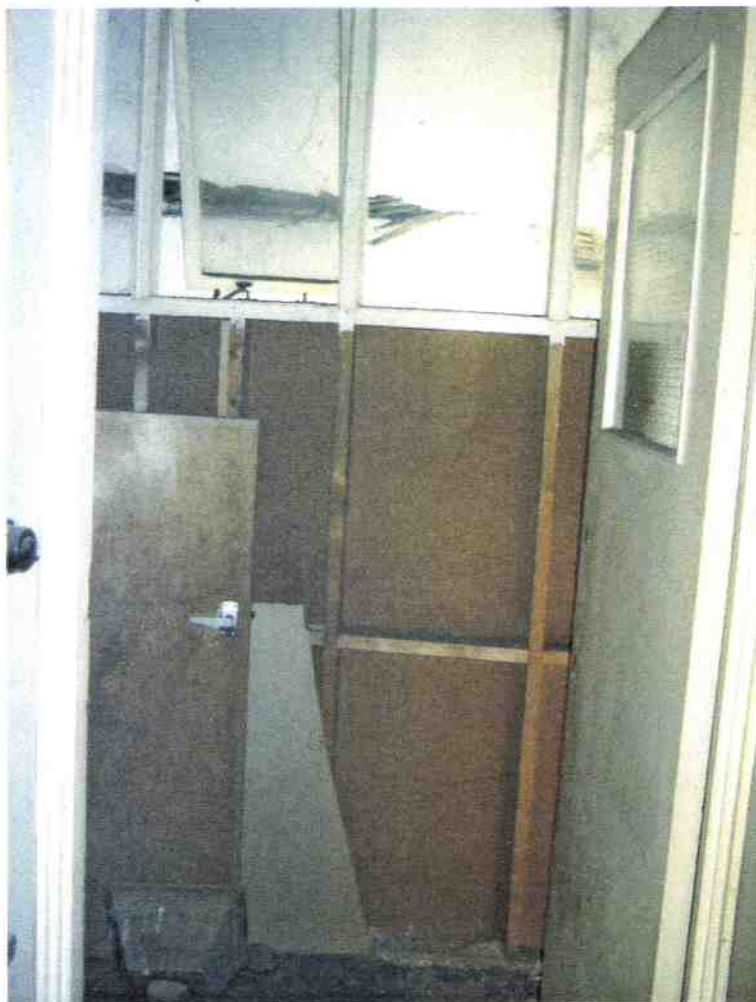
36. S9 D31 and internal hardboard partition.

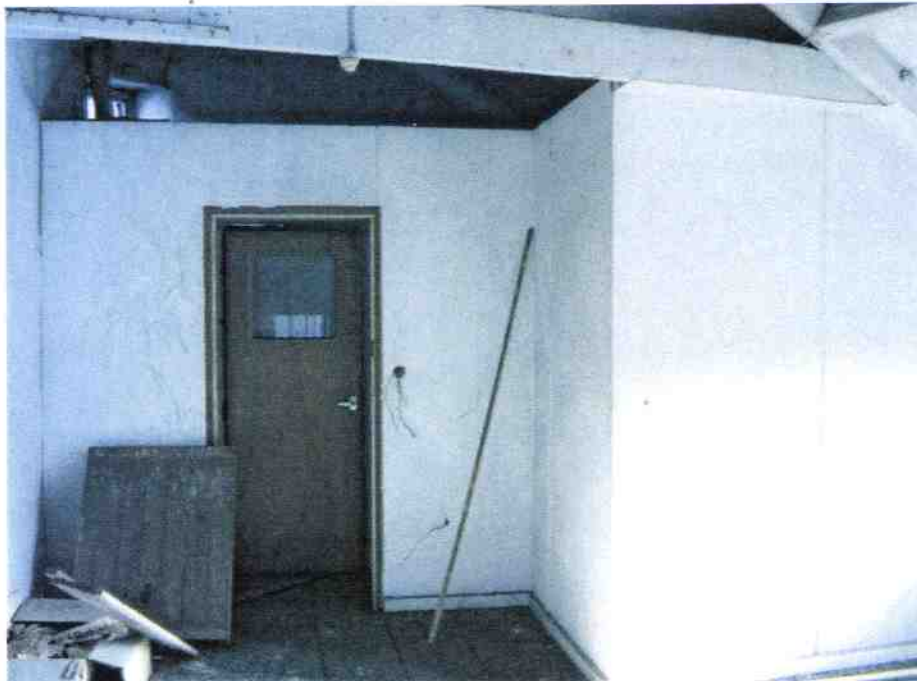
38. S8 Looking towards internal partitions to S9 and S10.  
D30 (open) in background.

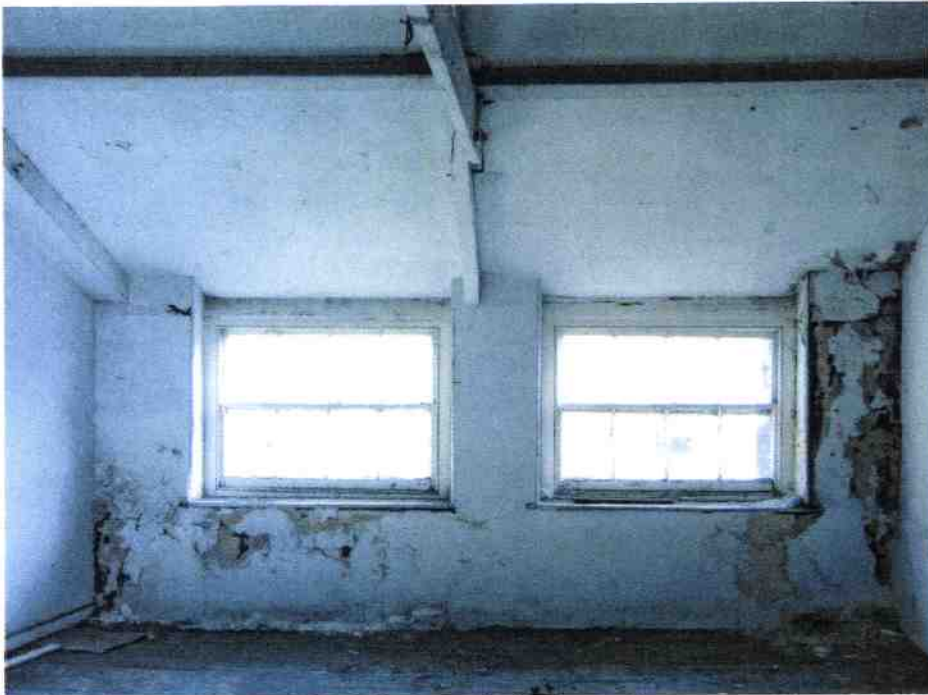
39. S8 W36 + W37. Lath and plaster ceiling.

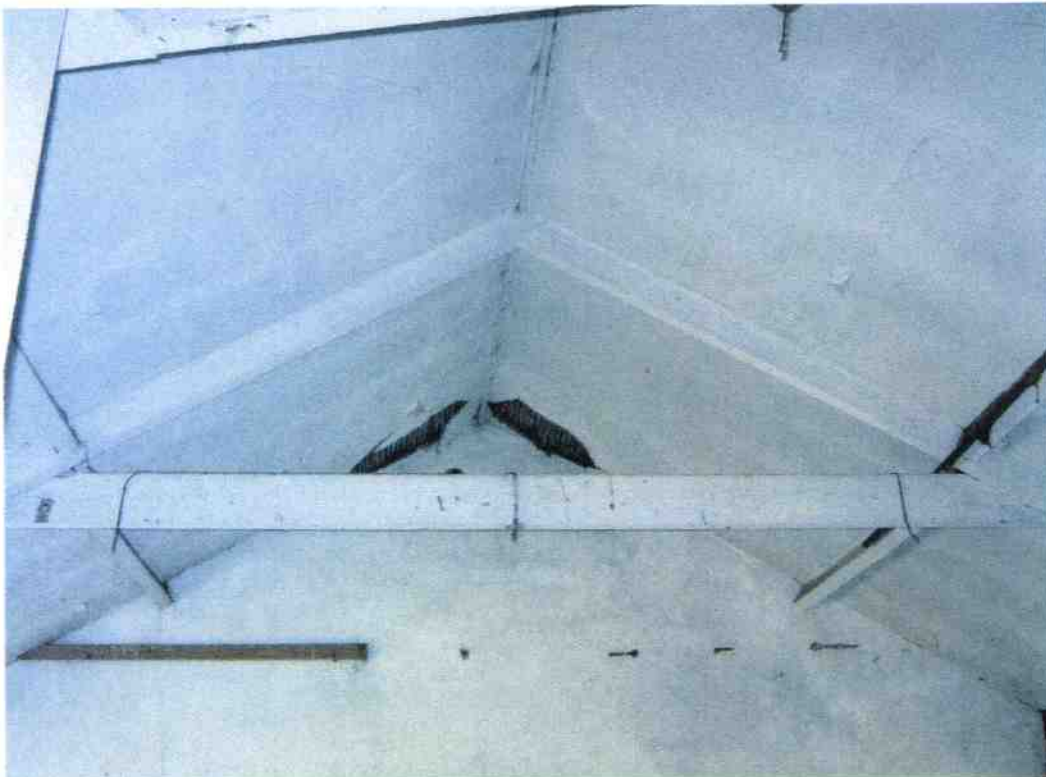
40. S8 Roof truss and collar – lath and plaster ceiling.

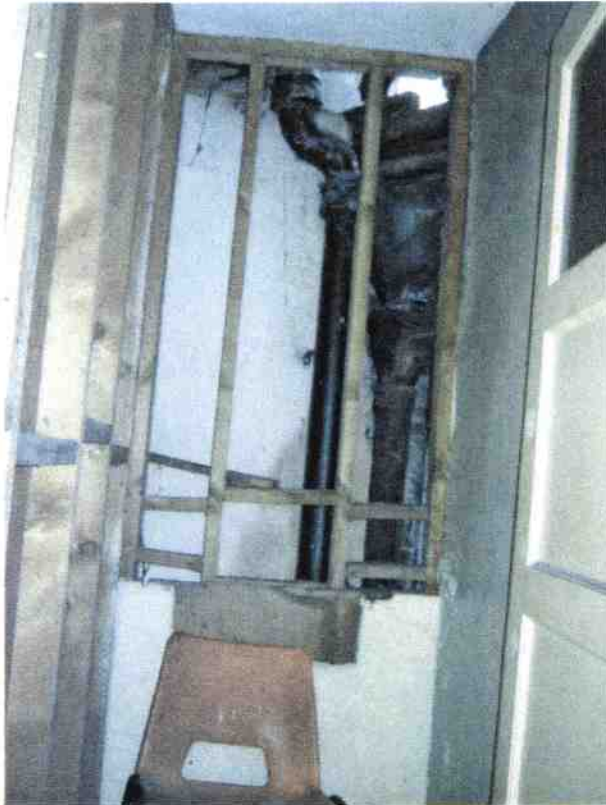
41. S10 View through door. (svp in background)

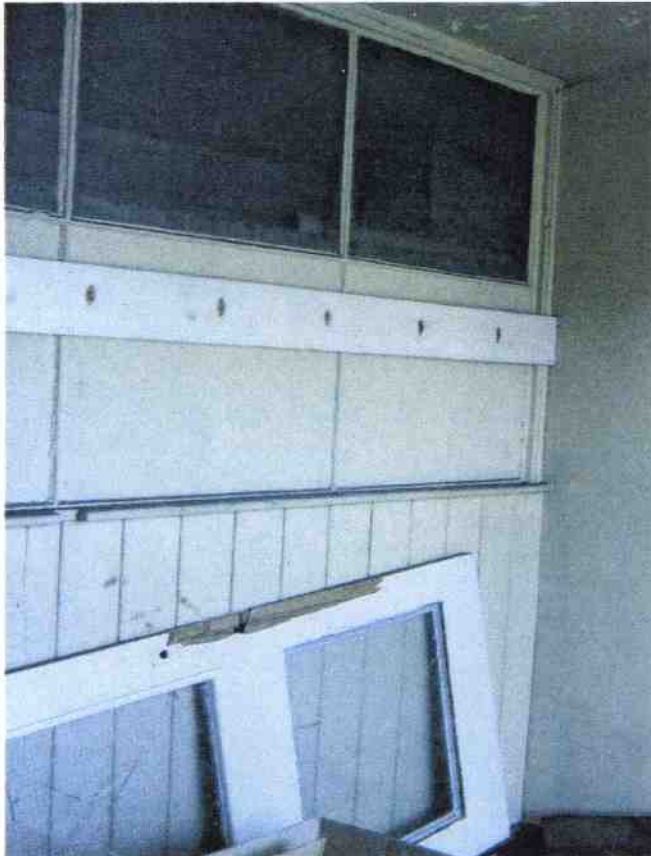
42. S12. Internal match board and glazed screen to S21

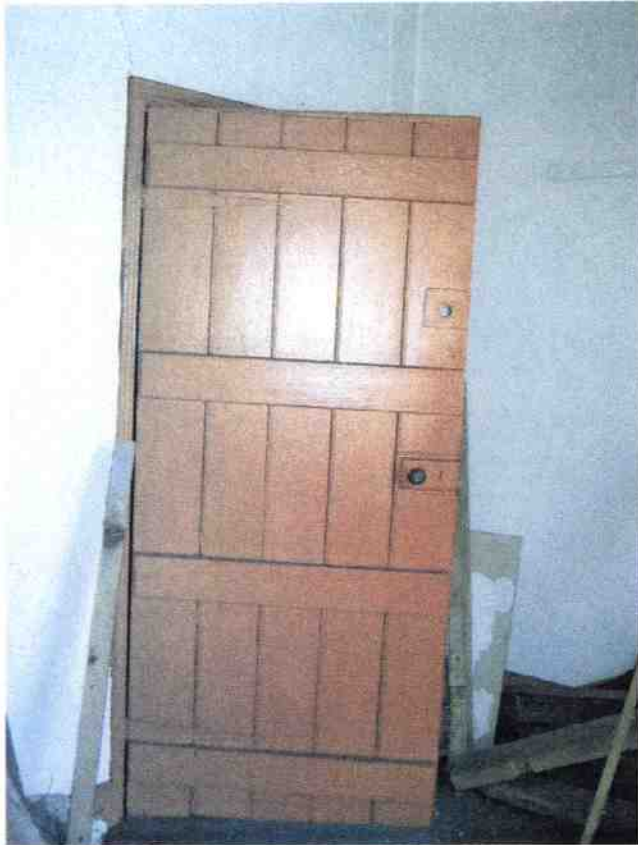
43. S13. Internal ledged and boarded door D38.

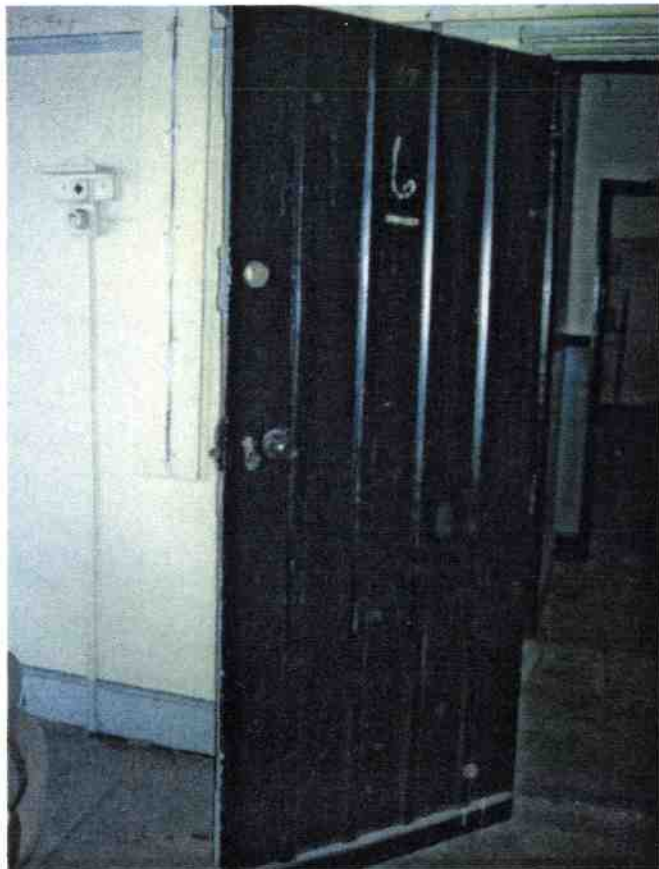
44. S14 D39 external face

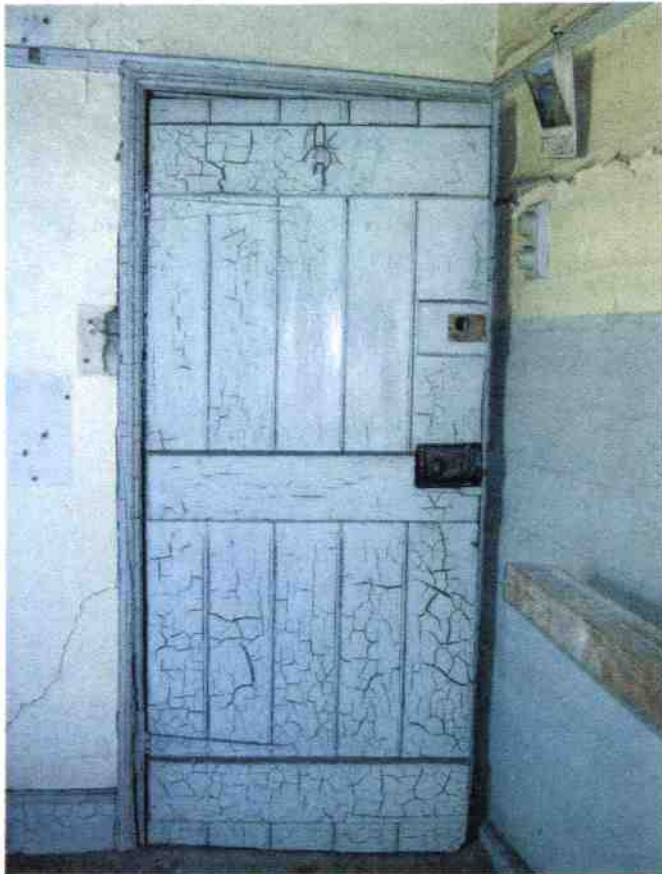
45. S14 D39 internal face
