LION HOUSE, COMMERCIAL STREET, PONTYPOOL.  
LBC ROOM CONDITION INSPECTION.

PHOTOGRAPHS.

13-P-00110

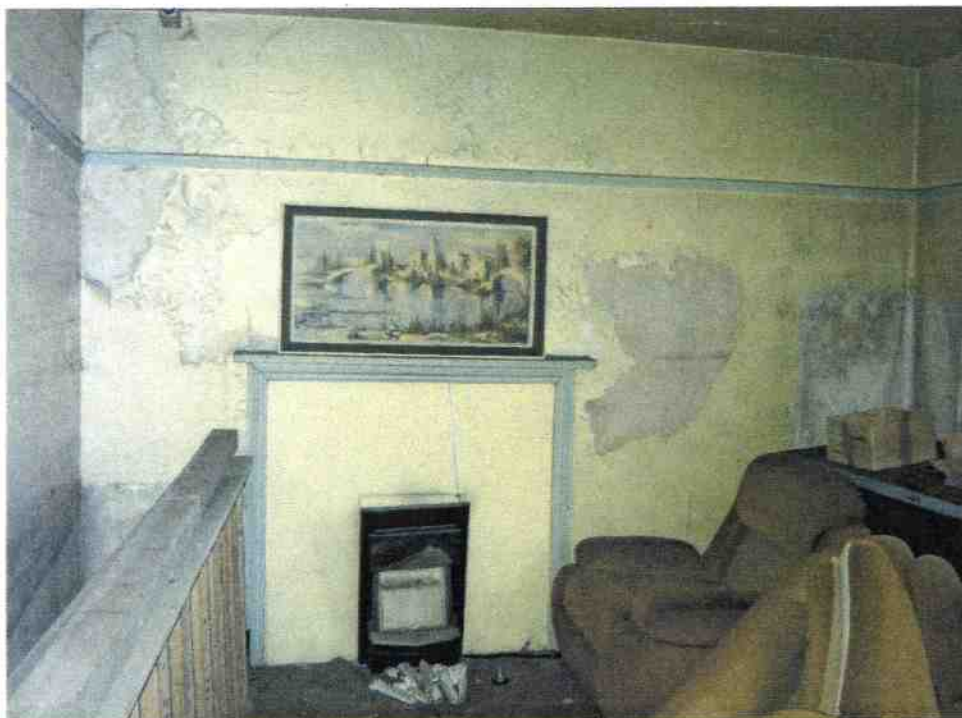
46. S14 Fire place and gas fire.

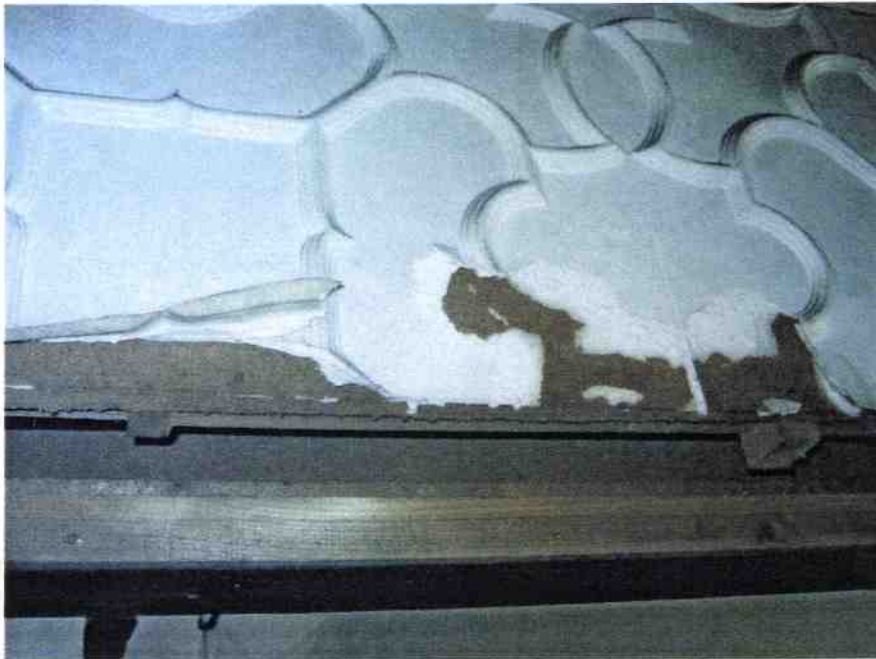
47. S16 detail of embossed ceiling paper.

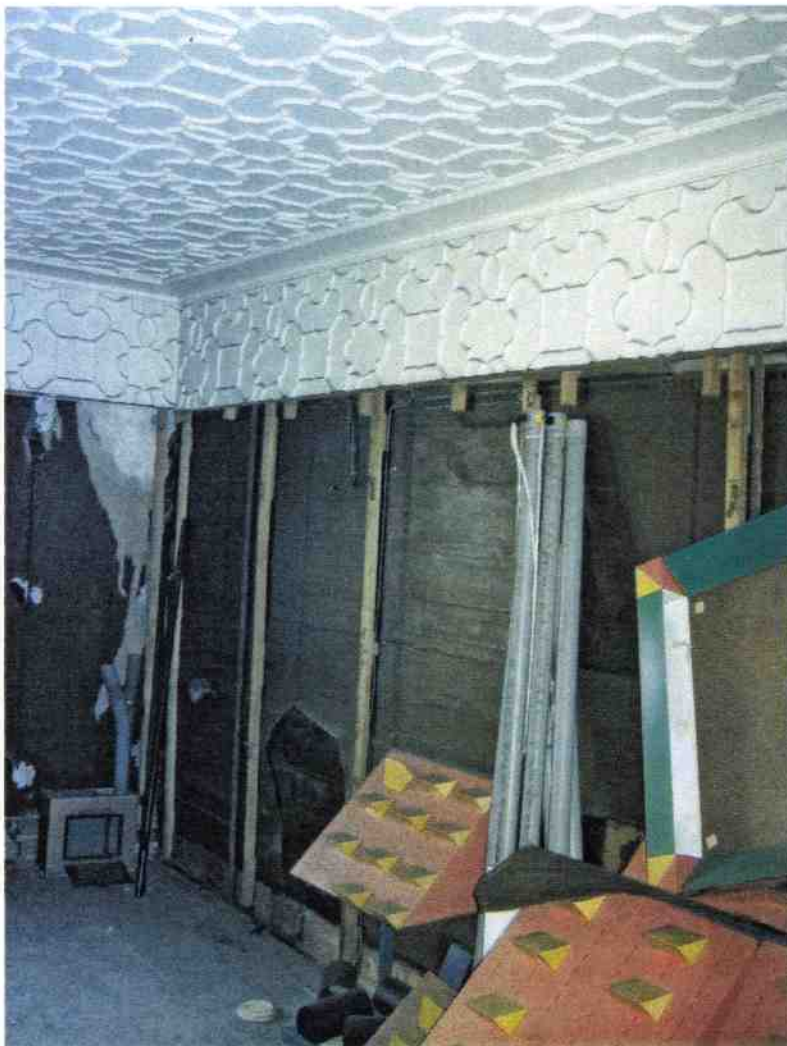
48. S15 View of part demolished partition and embossed ceiling paper

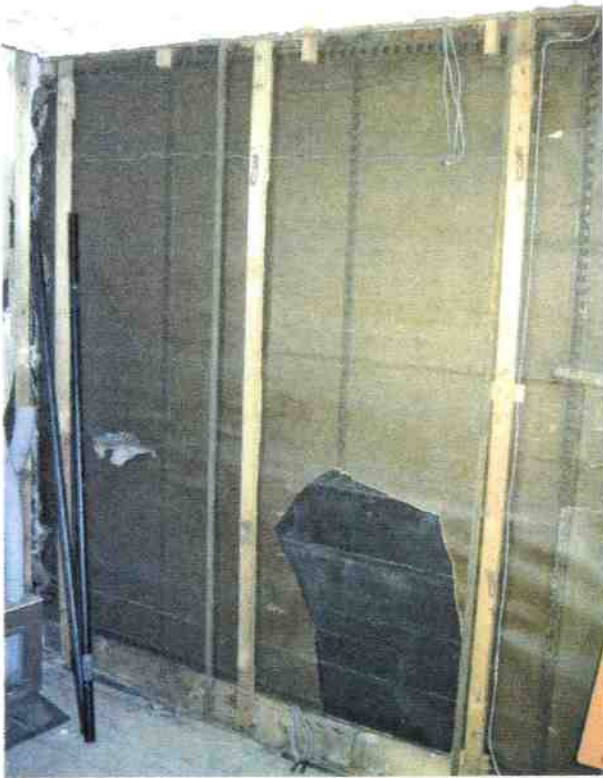
49. S15 View of part demolished partition and "leather" lining paper over timber boards.

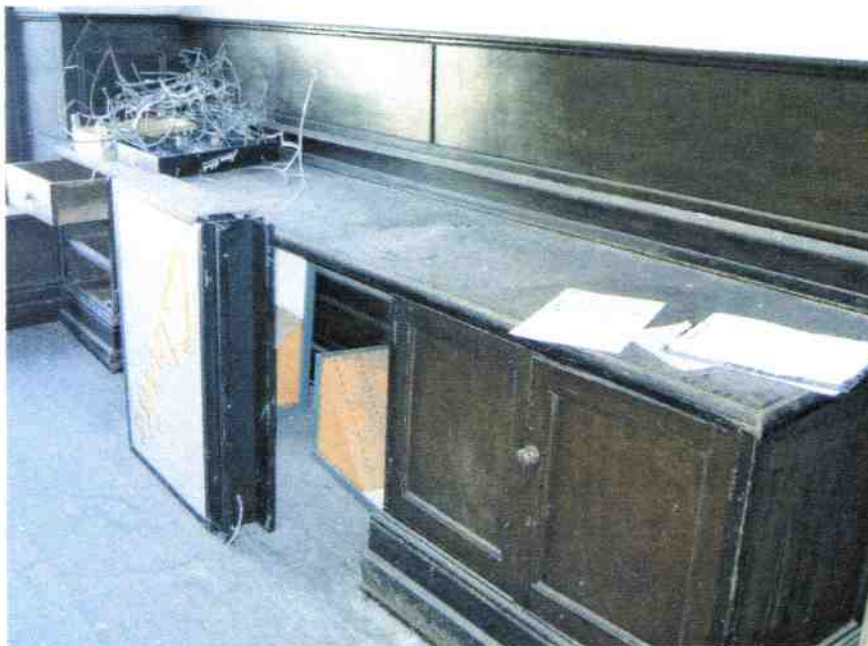
50. S16 Counter fitting – not a fixture.

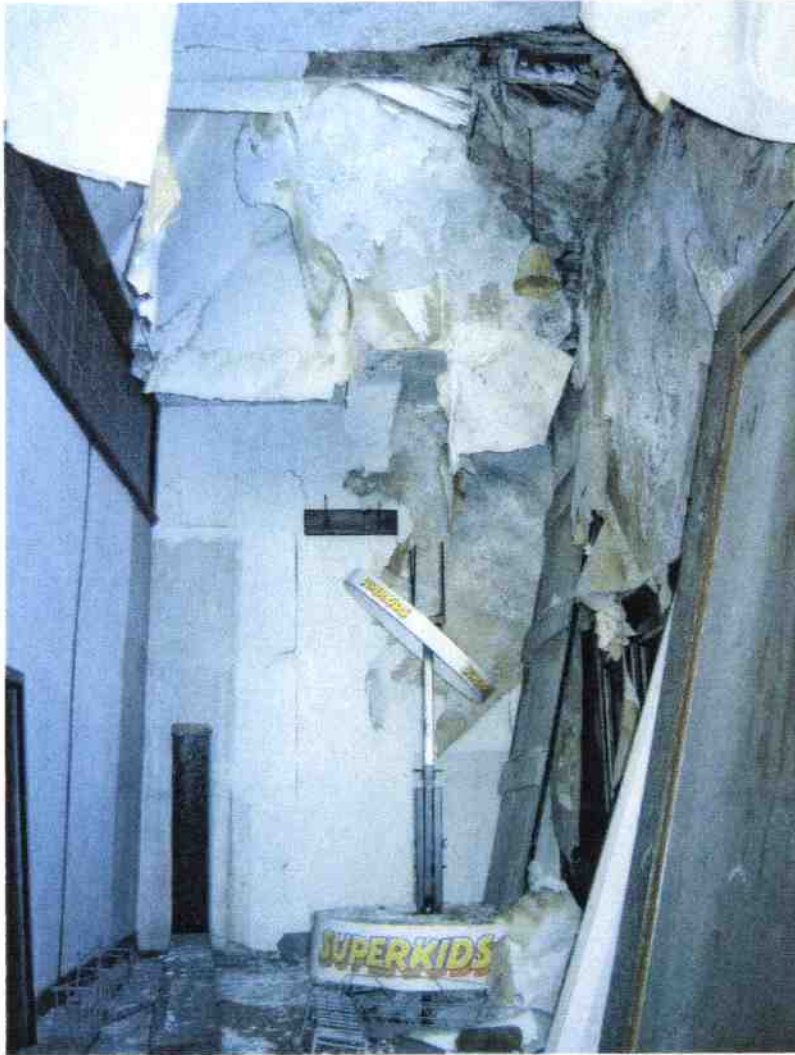
51. S16 rear cubicle area – derelict – severe water damage.

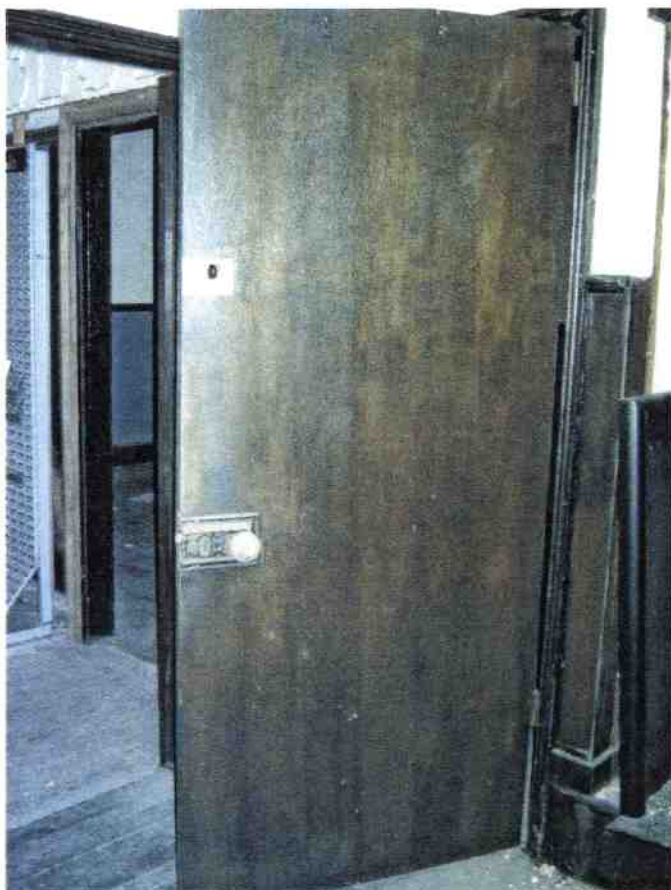
52. S16 D45 internal view. Varnished ply flush door.

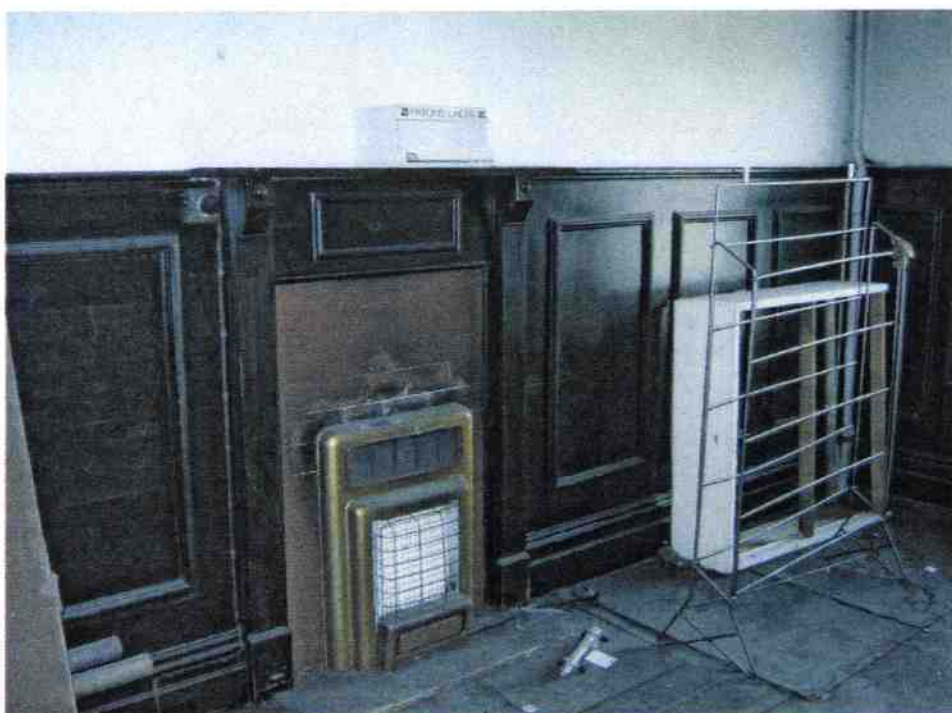
53. S16 Dado paneling (varnished ply) and gas fire.

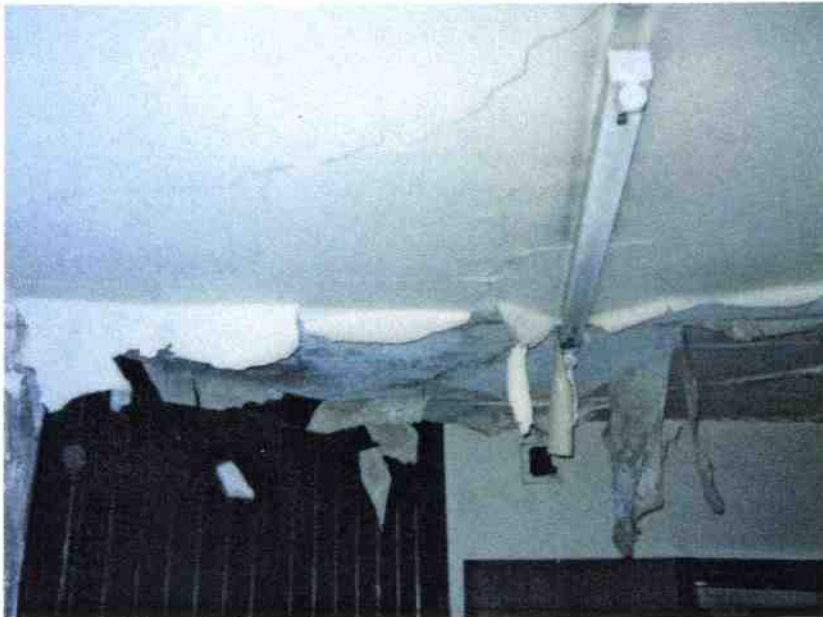
54. S17 Ceiling damage.

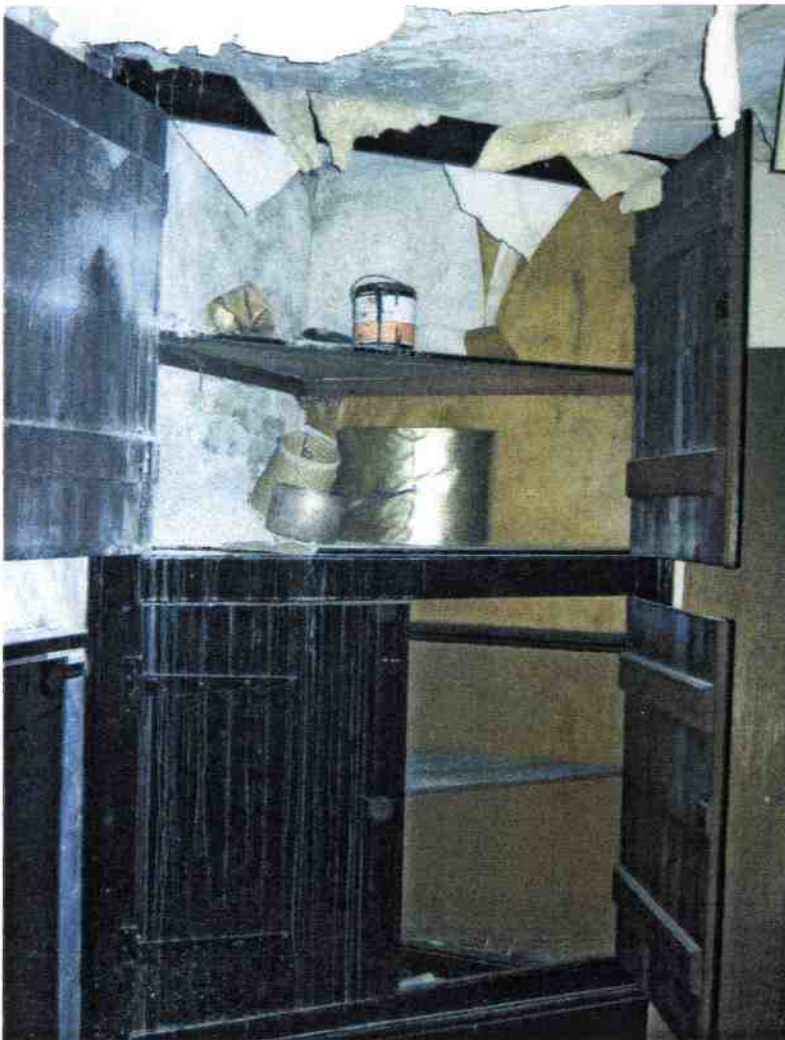
55. S17 Corner cupboard. Varnished soft wood.

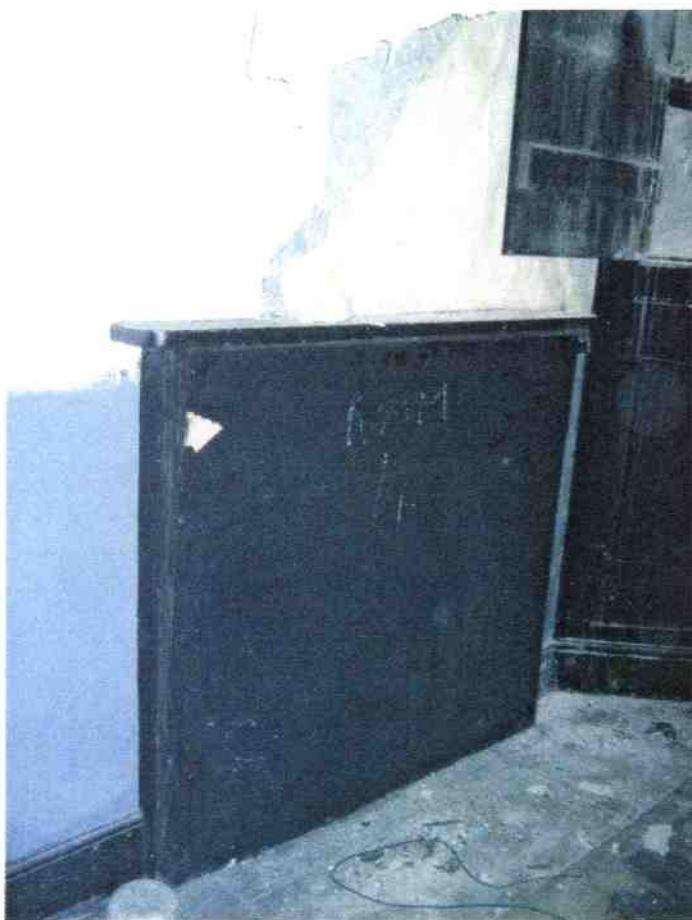
56. S17 Boarded fire place.

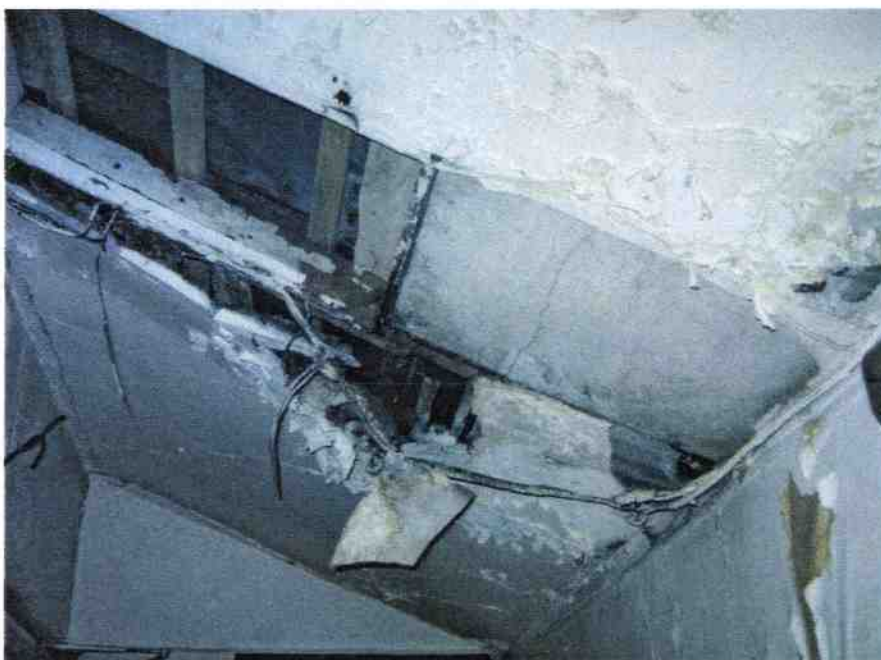
57. S18. Lean to roof – asbestos lining

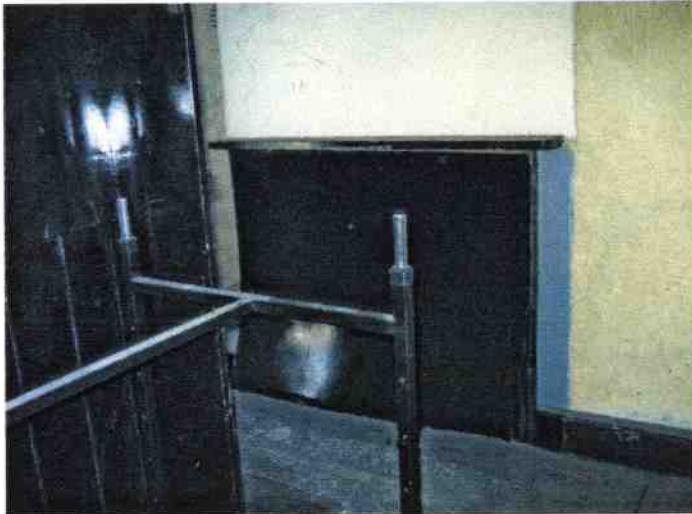
58. S21 Boarded fire place in circulation area adjacent to S12
