# **LION HOUSE, COMMERCIAL STREET, PONTYPOOL.**

## **GENERAL CONDITION SURVEY and ROOM CONDITION INSPECTION.**

13-00110

**January 2013**

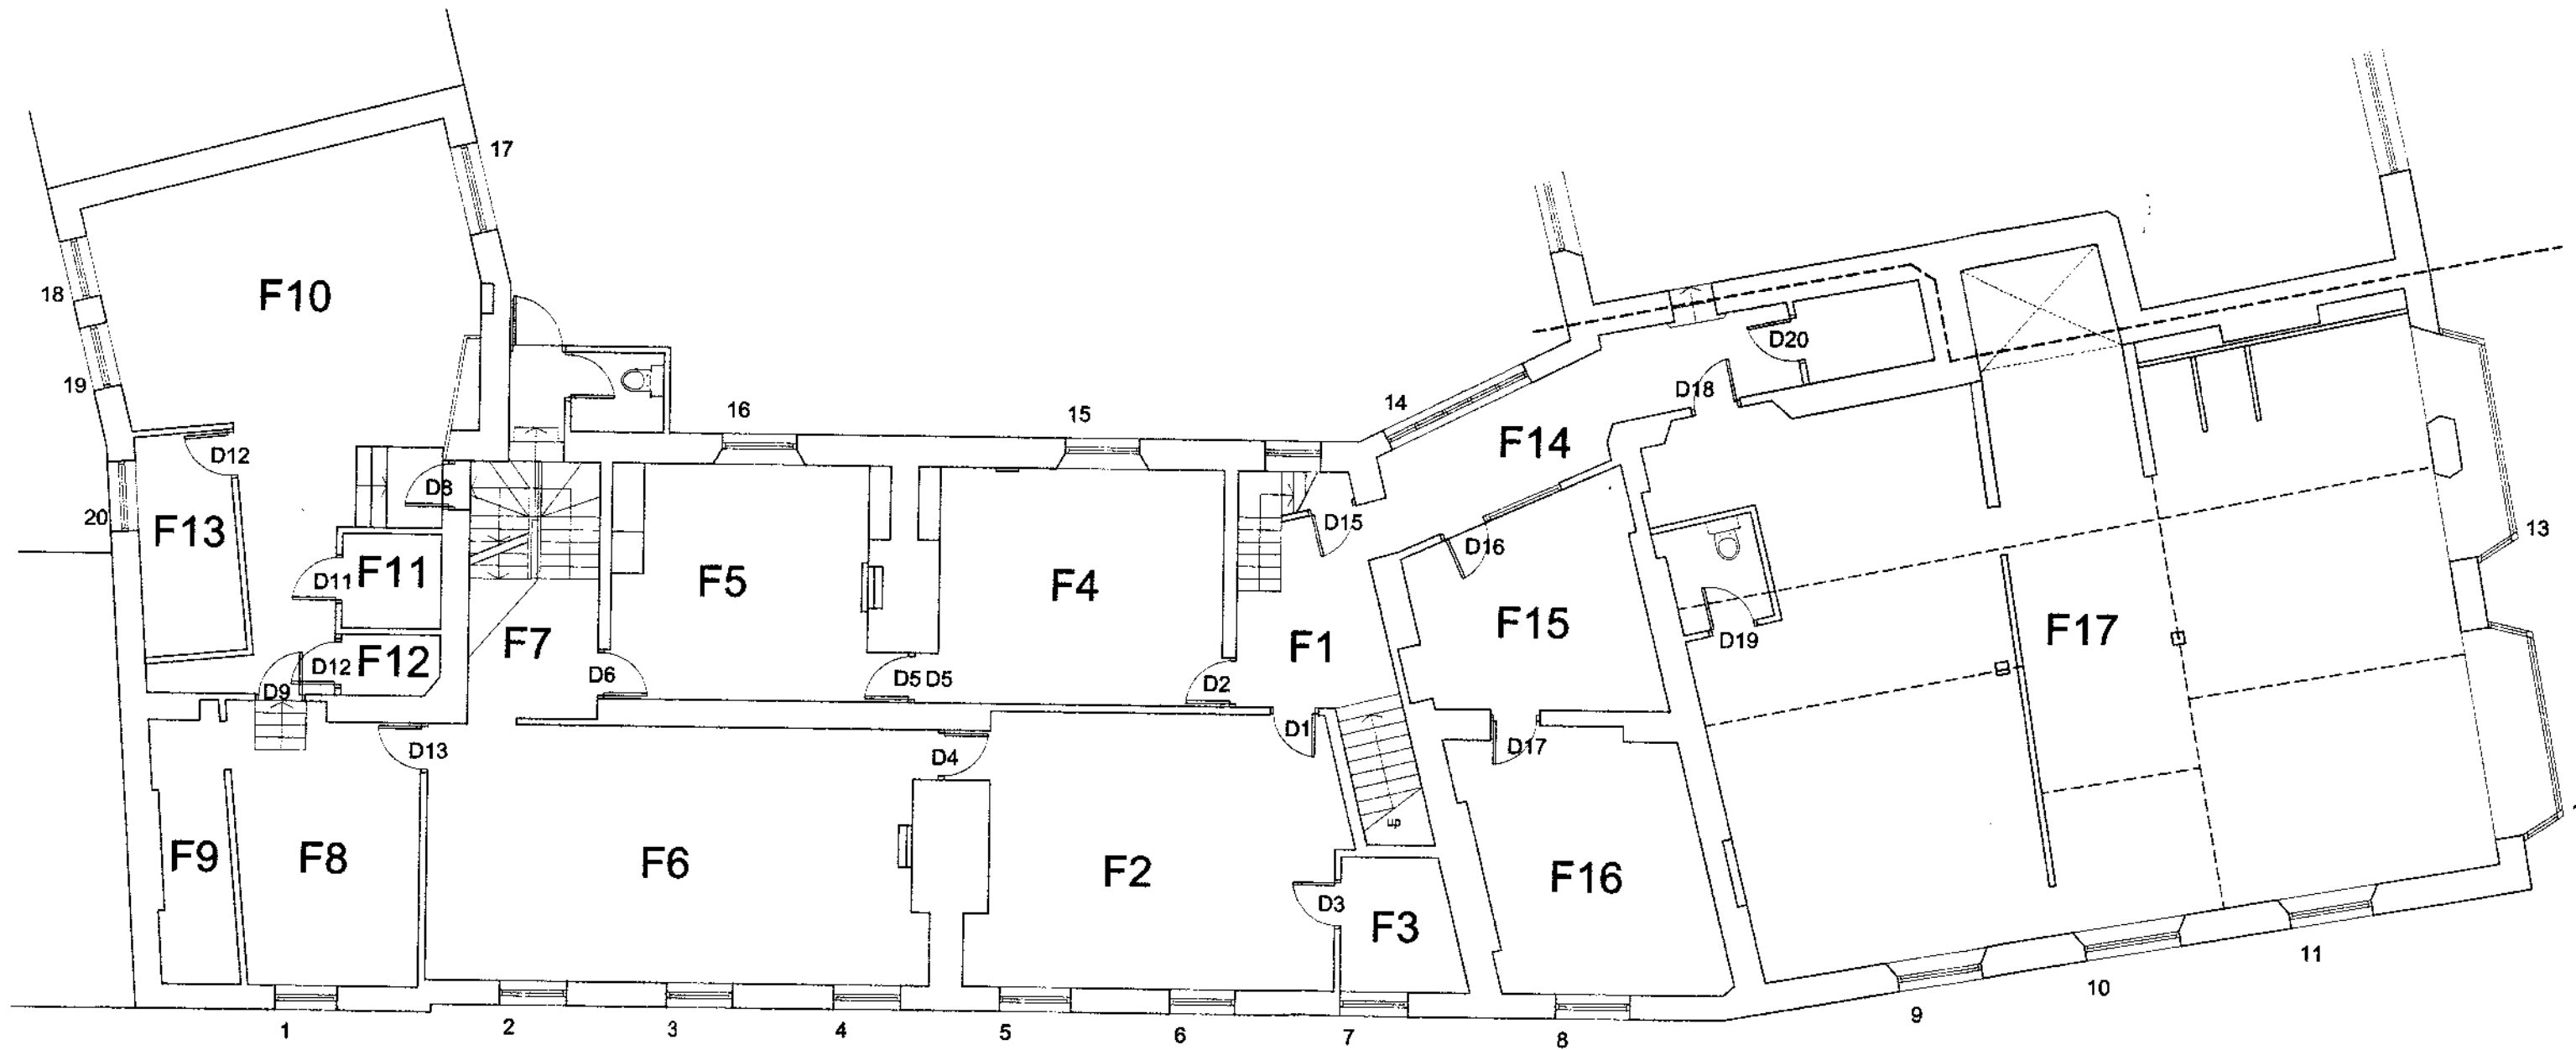
FIRST FLOOR EXISTING PLAN  
KEY PLAN - ROOM, DOOR AND WINDOW NUMBERS.

proposed extent of dry lining to external walls  
not to scale

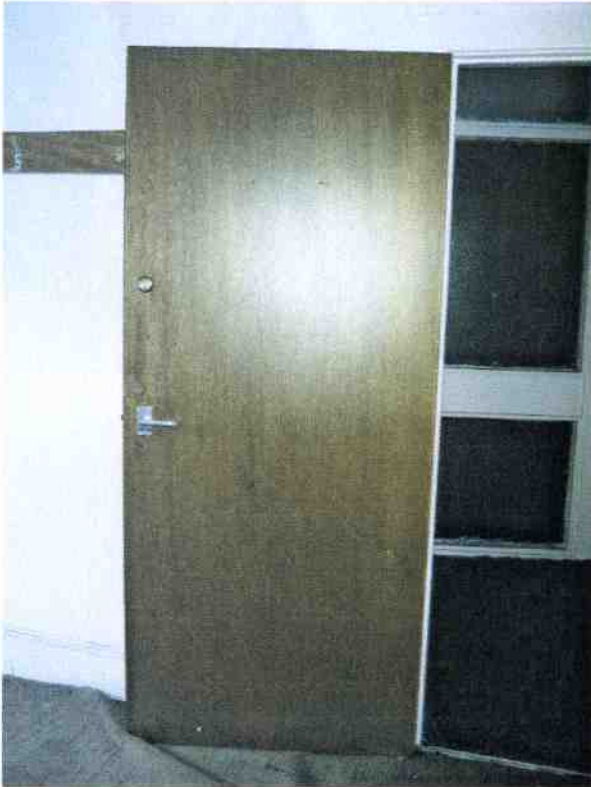
D22 typical veneered face flush ply fire door.

35mm flush doors are only suitable for wc's etc.

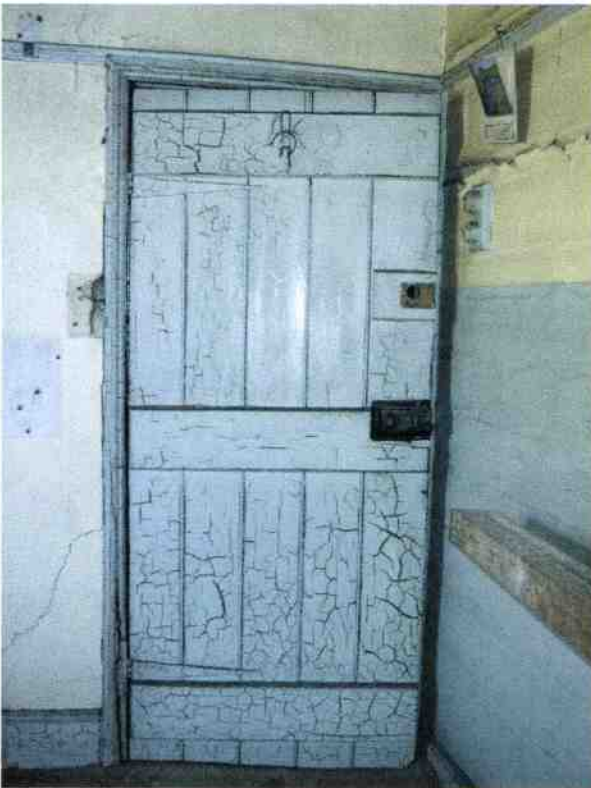
D39 rear face, ledged and braced door

- \* Doors 38 and 39 are "faked" up utility doors; 20mm vertical boards with horizontal; battens to rear with ply over face and vertical battens, suitable for cupboards only.
