# **LION HOUSE, COMMERCIAL STREET, PONTYPOOL.**

## **GENERAL CONDITION SURVEY and ROOM CONDITION INSPECTION.**

13-00110

**January 2013**

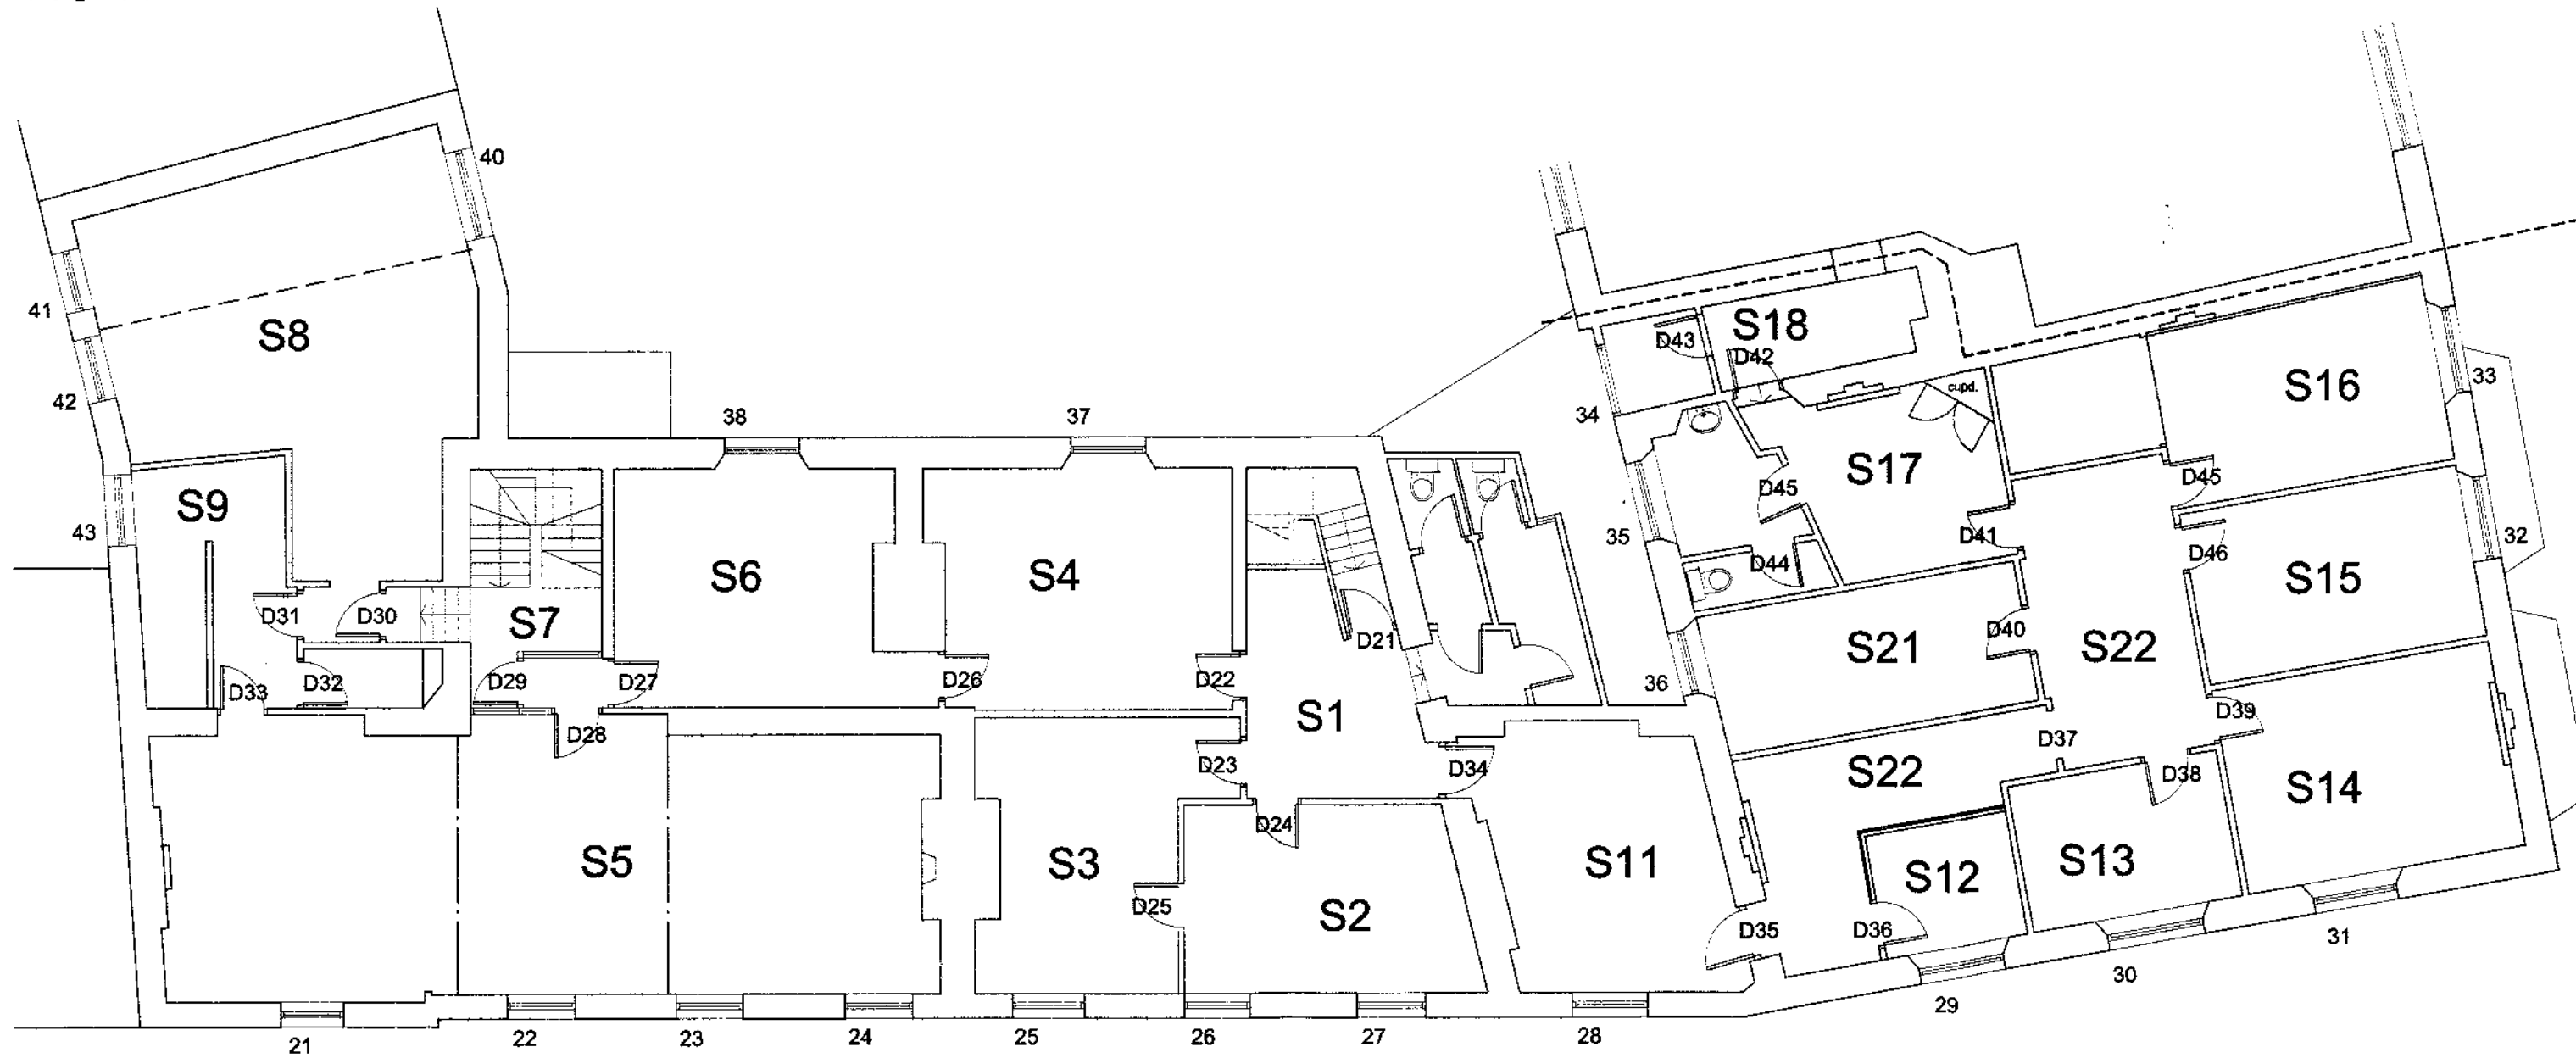
SECOND FLOOR EXISTING PLAN  
KEY PLAN - ROOM, DOOR AND WINDOW NUMBERS.

The building is robust with no significant structural disrepair or major defects. Water damage has affected the upper floor from leaks in the roof finishes and valley gutters. While this water damage has affected plaster finishes and the some areas of floor, none of this is detrimental to the structure itself notwithstanding the need to replace some localised ceiling and floor joists and the affected floor boarding itself. (rooms S1, S5, S16 annexe, S17 and S18.

Some minor deflection is apparent in the second floor above the Coop Bank at the north end of the building (rooms S12- S15). This appear to be a consequence of the removal of partitions on the first floor beneath this area of the building (room 17) and apparent where small beams are left suspended with no end support in the ceiling here. This has resulted in minor cracking in one non load bearing partition at its junction with the outer wall. This is not significant and is easily repaired with "stitching" techniques.

The repair of the floor will be straightforward once the significant partitions are replaced in the floor below (assuming the sub division of large space (F17) below into useful accommodation) The repairs would entail firing pieces to the existing floor joists to bring the floor to level before replacing the floor coverings.
